Applied Ion Systems

AIS-TR-001

AIS-uPPT1 Micro Pulsed Plasma Thruster

Testing Report and Failure Analysis

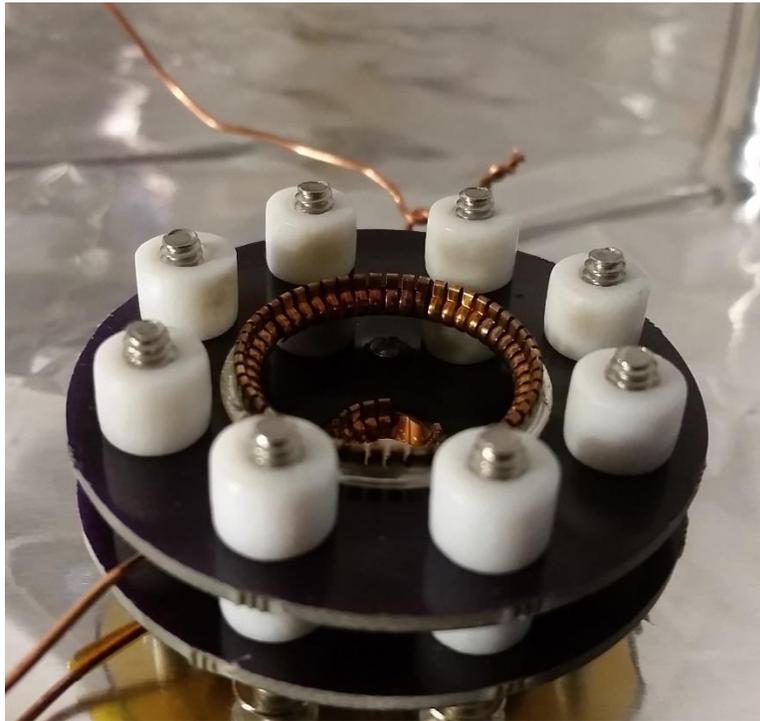
repetition rate of 1Hz, corresponding with the timed firing of the thyatron ignition pulser, behind the cathode connection board of the PCB socket assembly. It was initially suspected that this arcing may have occurred between the exposed cathode socket trace on the underside of the board, and the beryllium-copper fingerstock on the top of the ignition board. Upon demounting of the thruster from the chamber and disassembly, this arcing hypothesis was confirmed. Discoloration can be seen on several of the Teflon spacers between the cathode and ignition board from the arcing in *Figure 1* and *Figure 2*. Close visual inspection, as well as inspection under an optical microscope, also reveals ablation of the gold-plated cathode trace underneath the cathode connection board in *Figures 3-5*. Light discoloration of the ignition board fingerstock can also be observed.

FIGURE 1 – Cathode-Igniter board Teflon spacer charring due to ignition discharges.

The primary underlying cause of ignition failure ultimately results from the inherent design of the thruster. Although the ignition electrode to cathode spacing is uniformly 0.028” concentrically between the two electrodes, and much closer than the 0.126” spacing between the ignition fingerstock and the cathode connection board trace, arcing still occurred in the wrong location, and failed to ignite the thruster. It is suspected that the highly polished and smooth stainless steel surfaces of the electrodes inhibited breakdown, where the sharp edges of the beryllium-cooper fingerstock in the ignition electrode connection PCB caused much higher local field enhancement, promoting discharge despite the wider spacing.

Due to the tight spacing of the boards based on small-satellite space constraints, it is highly recommended to implement additional board-to-board insulation between surfaces of adjacent-facing boards. It is in this region where the arc faults during testing occurred when pushed to higher voltages. Such insulation can include laser-cut Kapton sheets with the same board pattern, or Teflon sheets with tight fits near exposed metal surfaces. Solder mask over any unsoldered surface traces may also help mitigate arc faults between boards.

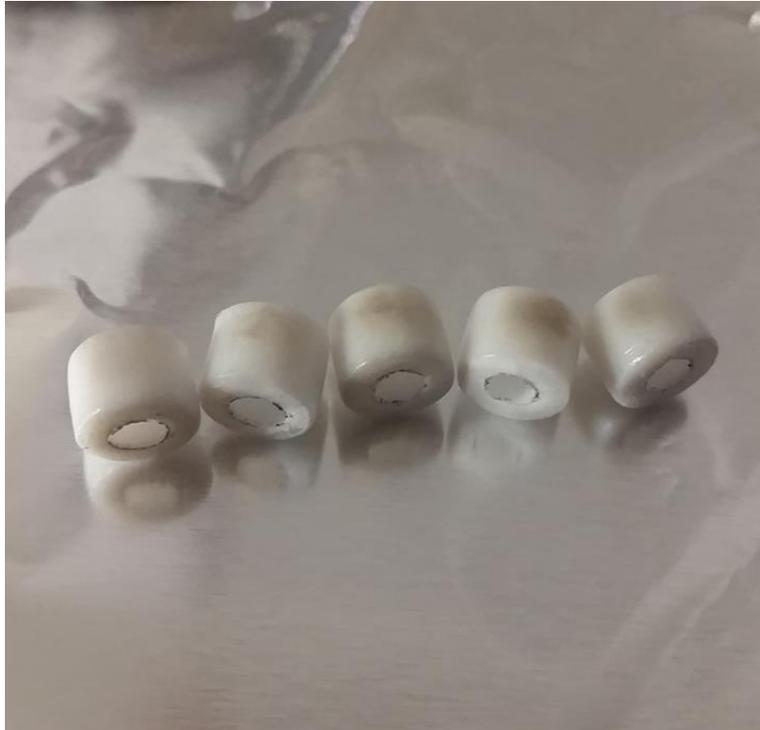
FIGURE 2 – Cathode-Igniter board Teflon spacer charring due to ignition discharges.

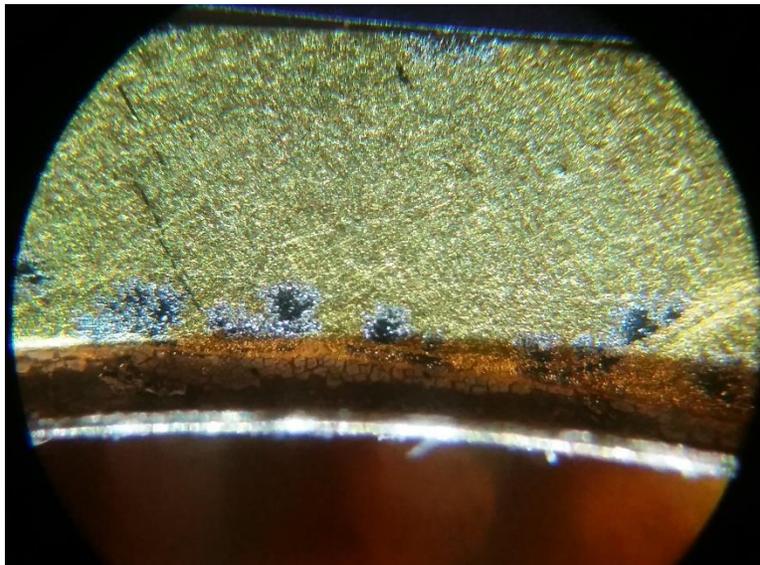
FIGURE 3 – Cathode board trace ablation from ignition arcs.

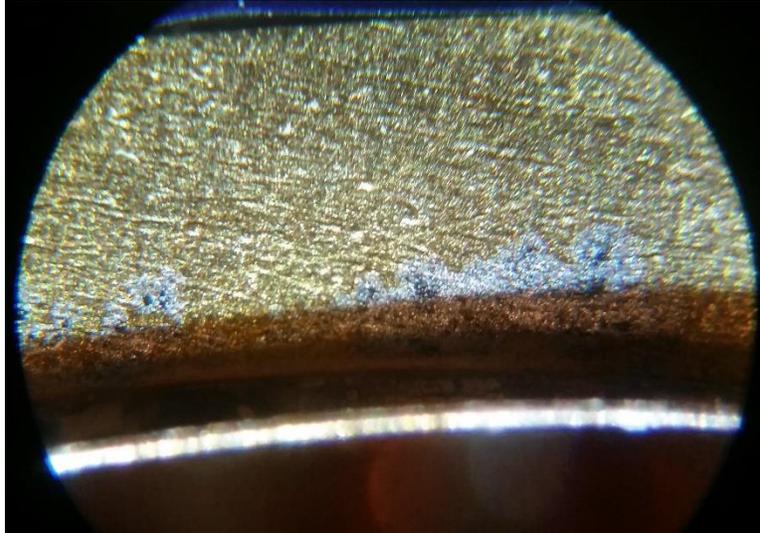
FIGURE 4 – Cathode board trace ablation from ignition arcs.

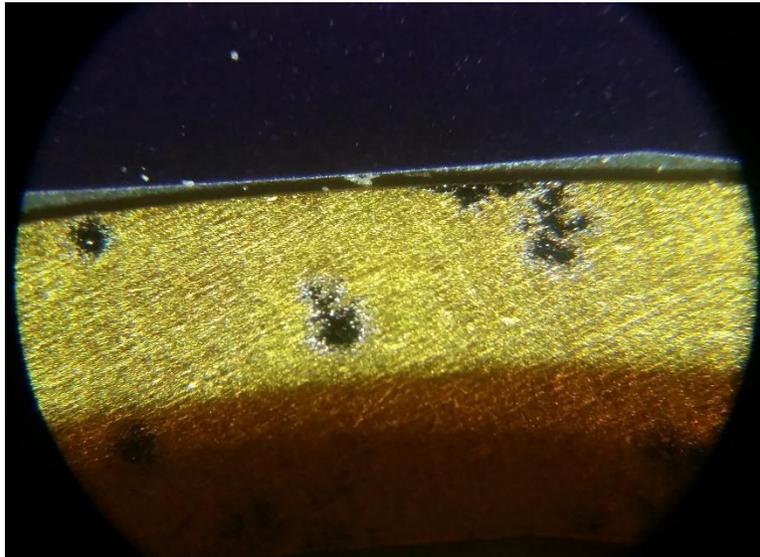
FIGURE 5 – Cathode board trace ablation from ignition arcs.

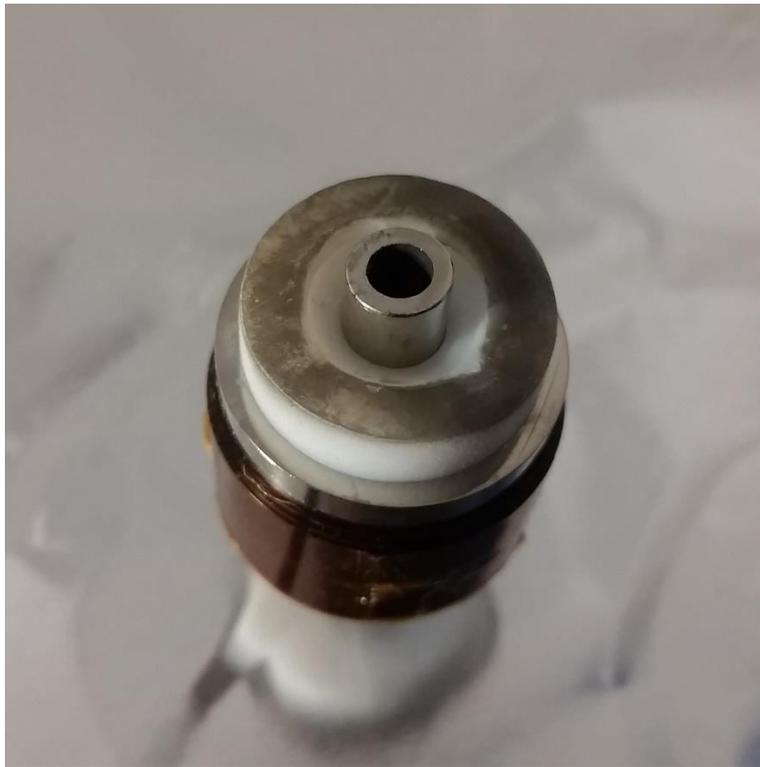
A second failure was noted during testing. For several random pulses after ignition, the main capacitor discharged a plasma pulse further back in the PCB socket assembly. This only occurred when the main capacitor was brought to its maximum voltage level of 2kV. Upon disassembly and inspection of the thruster, it was immediately noticed that the thruster fired an ablative pulse of the Teflon fuel at the rear of the thruster socket, between the central anode connection fingerstock, and the outer stainless steel assembly bolts, which also serve as low-inductance ground connections for the cathode. This shows successful firing and ablation of the Teflon fuel radially, however this occurred in the wrong part of the thruster. Charring from the ablation of the Teflon fuel can be seen in *Figure 6*. *Figure 7* shows board damage and charring due to the firing of the thruster in the wrong area along the anode board surface under the Teflon fuel. *Figure 8* shows subsequent charring of the Teflon spacers between the ignition and anode

FIGURE 6 – Teflon fuel charring from ignition on the anode board surface.

A further potential redesign suggestion includes the use of separate voltages on the anode board, and placing a direct connection to the cathode board. In the original design, the anode board includes the central anode fingerstock connection, and the cathode connection on the periphery, where the stainless steel bolts make a low-inductance and evenly-distributed contact to the upper cathode board. By eliminating this configuration, and using direct connection to the cathode board through a connecting wire, chances of main capacitor discharge failure across the board can be eliminated. PEEK hardware can also be employed for non-conductive assembly of the boards in the socket.

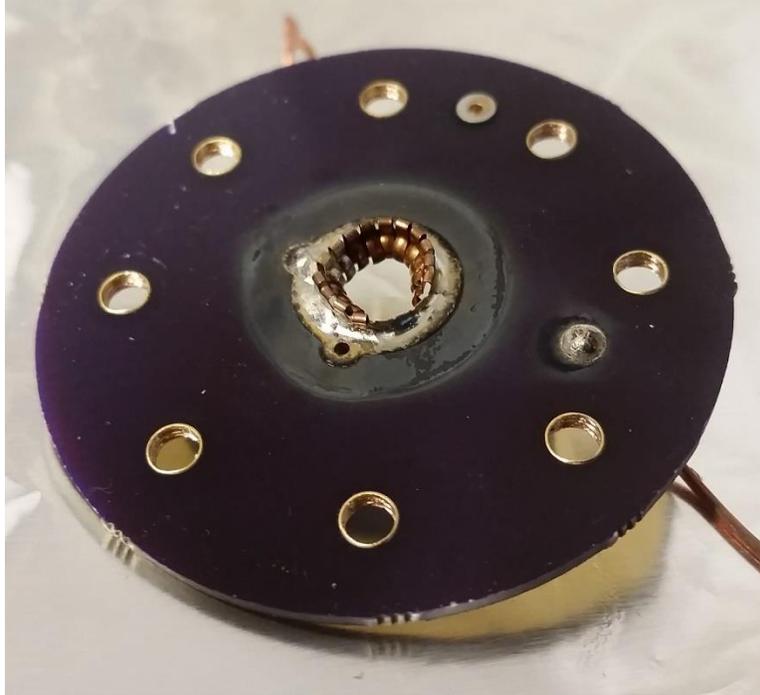
FIGURE 7 – Charring of the anode board surface due to ablation of the Teflon fuel.

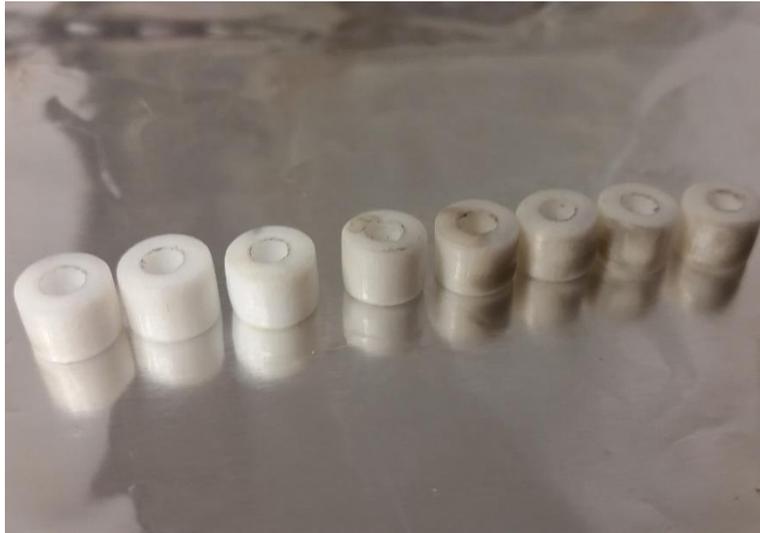
FIGURE 8 – Charring of the Teflon spacers between the anode and igniter boards.

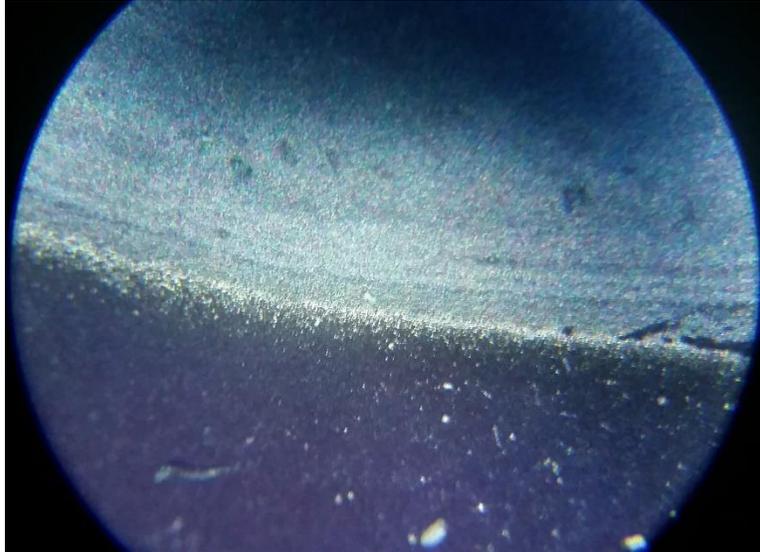
boards. *Figures 9-11* show microscope photos of the charring damage of the board due to ignition on the Teflon fuel. In particular, *Figure 11* shows evidence that this ignition was initiated between the central anode socket fingerstock trace, and a cathode connection solder hole. In *Figure 12*, the back of the anode board shows ablation of the surface traces due to arcing. A close-up microscope shot in *Figure 13* reveals significant ablation around the same hole where the suspect initial discharge occurred and was identified in *Figure 11*. It is suspected that the initial ignition arcing in the PCB socket assembly raised localized pressure within the socket due to ablation of the traces during the pulse to allow for the main capacitor to discharge between the anode and cathode connections in the socket assembly.

FIGURE 9 – Charring and ablation of the anode board surface due to ignition of Teflon fuel. Comparison between boundary layer of ablation and normal board surface.

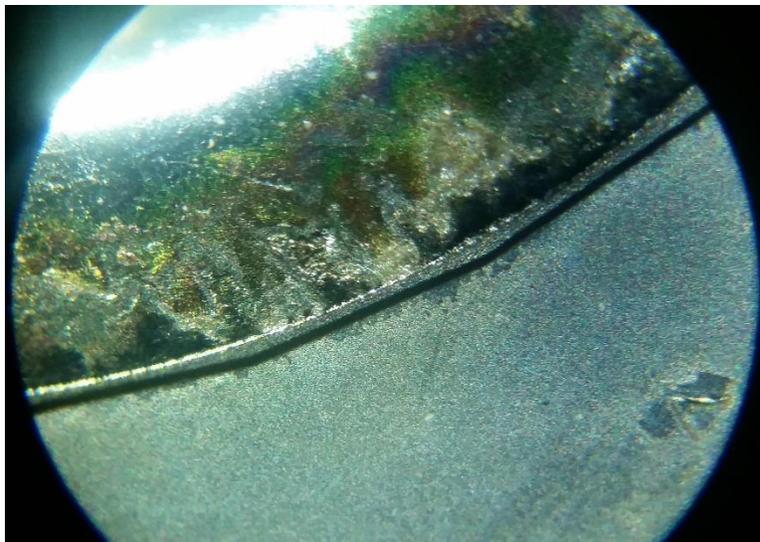
FIGURE 10 – Charring and ablation of the anode board surface due to ignition of Teflon fuel. Comparison between fingerstock solder trace and the ablated area of the board.

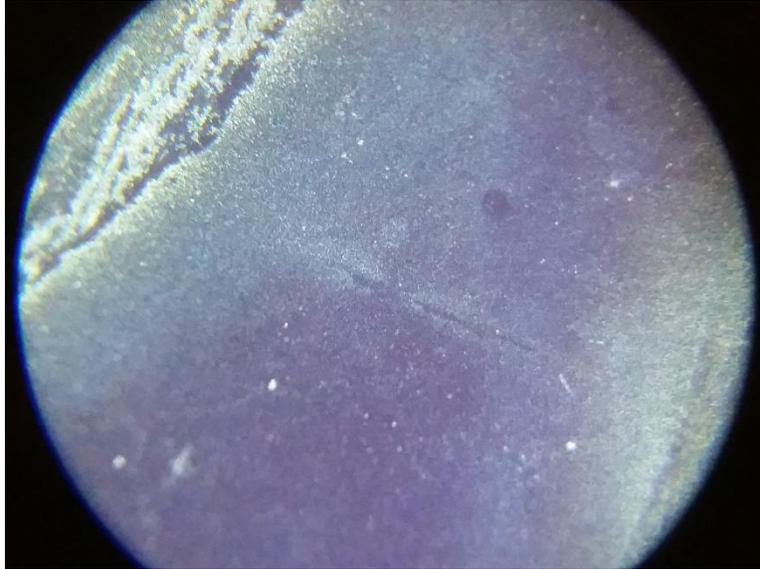
FIGURE 11 – Charring and ablation of the anode board surface due to ignition of Teflon fuel. Possible arc ignition and formation source between anode fingerstock connection (left) and cathode solder point connection (right).

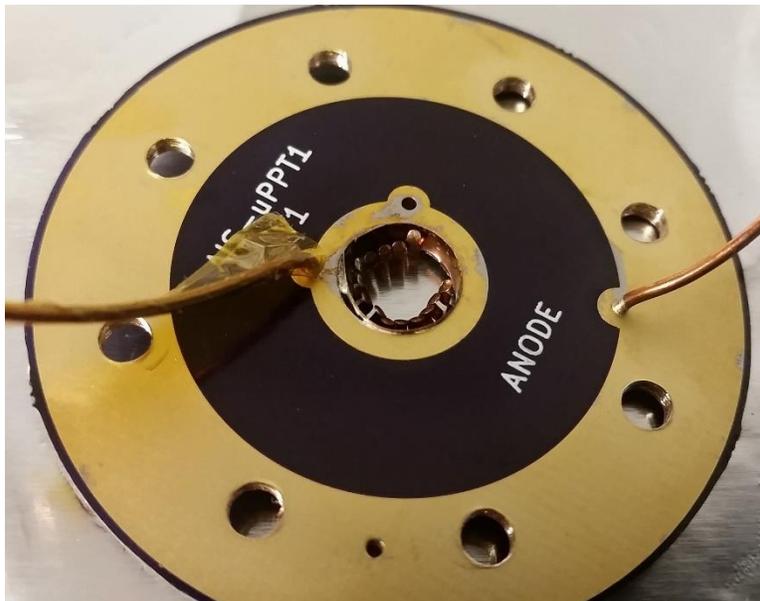
FIGURE 12 – Ablation of the anode board surface traces due to arcing.

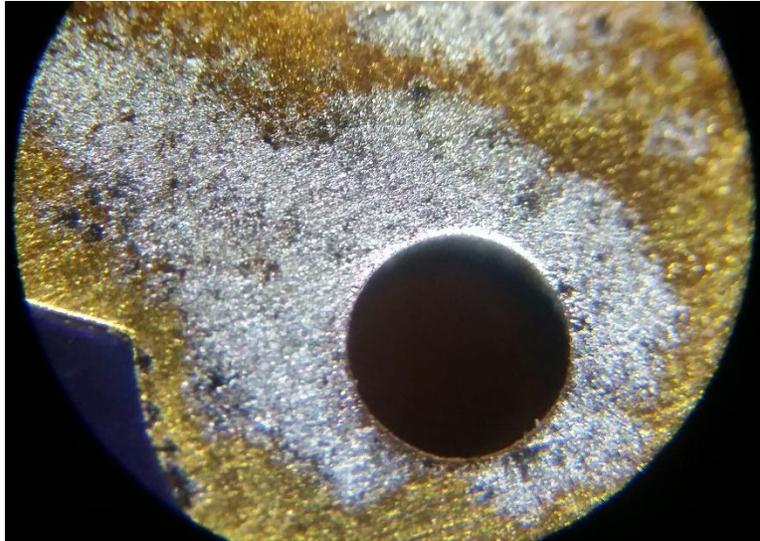
FIGURE 13 – Microscope picture of anode board surface trace ablation due to arcing. This ablation is present around the arc ignition point identified in Figure 11.
