Applied Ion Systems

AIS-TR-002

AIS-gPPT1 Gridded Pulsed Plasma Thruster

Testing Report and Failure Analysis

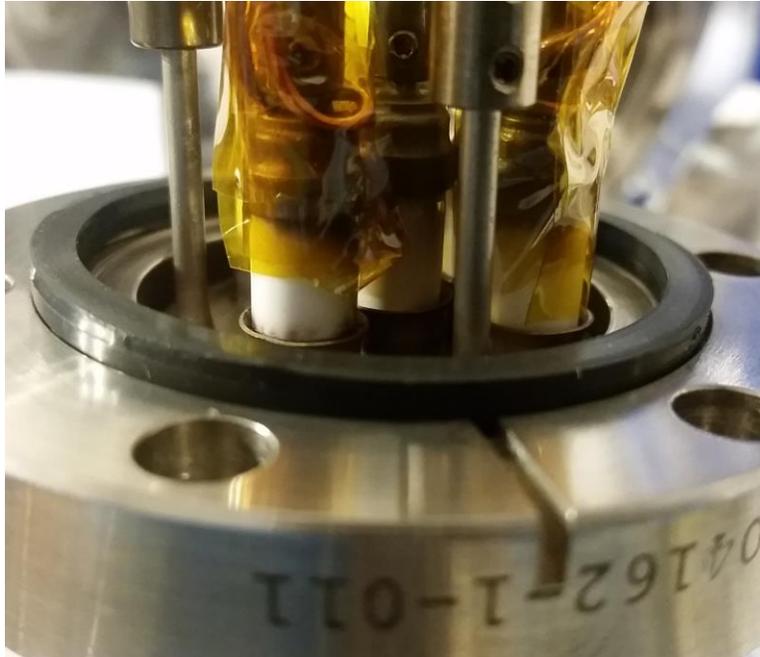
FIGURE 1 – Arcing around ceramic insulators at the base of the conflated feedthrough.

In the prior ignition test performed two days before with the AIS-uPPT1 Micro Pulsed Plasma Thruster, an identical setup was used, except that no Kapton tape was present along the connection wires in the chamber. It is therefore believed that the adhesive from the Kapton tape caused the arcing and flashovers at these locations. This is potentially due to higher outgassing of volatiles of the possibly lower quality generic Kapton tape.

The primary cause of internal arcing failures was determined to be the direct result of the Kapton tape adhesive. Arcing faults occurred consistently at exposed ends of the tape at the conductors, which was not present in prior ignition testing. It is recommended to refrain from using any Kapton tape for insulating any high voltage or pulsed connection wires in the vacuum chamber. Instead, if insulation is desired, Teflon or ceramic tubing should be used along the entire length of the wire. UHV compatible wire such as Kapton or Teflon insulated wire can also be substituted. Care must be taken to avoid any sharp connection points, or exposed conductors, keeping wires at a maximum distance as feasibly possible.

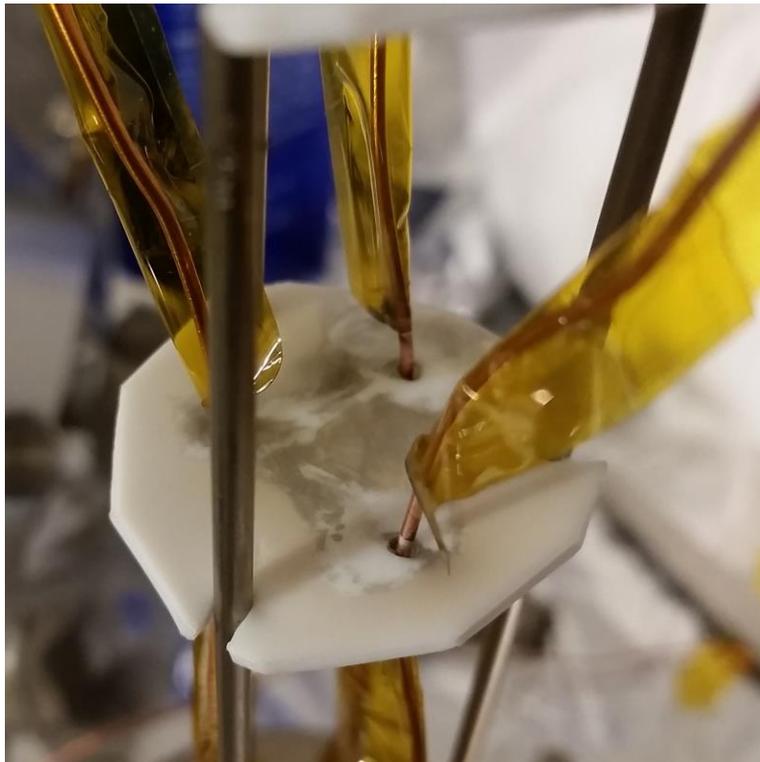
FIGURE 2 – Arcing at the wires around the upper Teflon wire spacer.

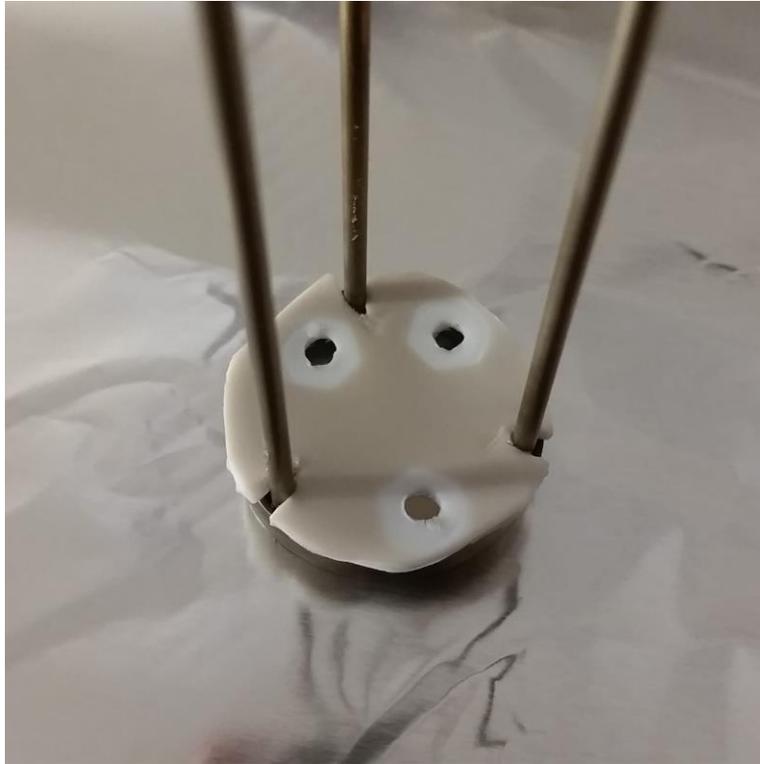
Several key failures were identified during and after the Phase I ignition test. During the test, as ignition voltage was increased, the ignition pulse could eventually be observed flashing at the set repetition rate of the function generator, corresponding with the timed firing of the thyatron ignition pulser, behind the thruster. At several instances, when main bank voltage was at its peak, a plasma ignition occurred in this area as well. Upon disassembly and inspection of the system after testing, it was discovered that all arcing faults occurred at exposed edges of Kapton tape insulating the bare copper connection wire. This occurred in two major areas: at the high voltage feedthroughs at the base of the conflat feedthrough (*Figure 1*), and between the wires along the thruster holder, which are set and spaced with a Teflon wire holder (*Figure 2*). Yellowish discoloration around the Teflon and stainless steel thruster mounts also show that Kapton ignition had occurred during the main bank discharges. This can be seen clearly in *Figure 3*, on the underside of the Teflon thruster mount.

FIGURE 3 – Ablation residue from Kapton ignitions.
