# Applied Ion Systems

AIS-TR-005

## AIS-gPPT2-1C Gridded Pulsed Plasma Thruster

End of Life Report

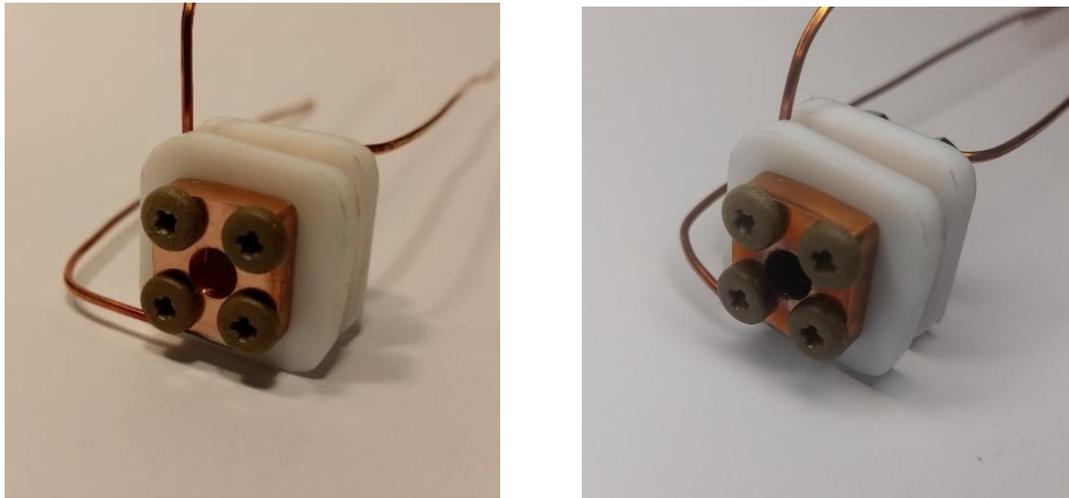
*FIGURE 1: Before testing (left) and after testing (right) of the AIS-gPPT2-1C thruster.*

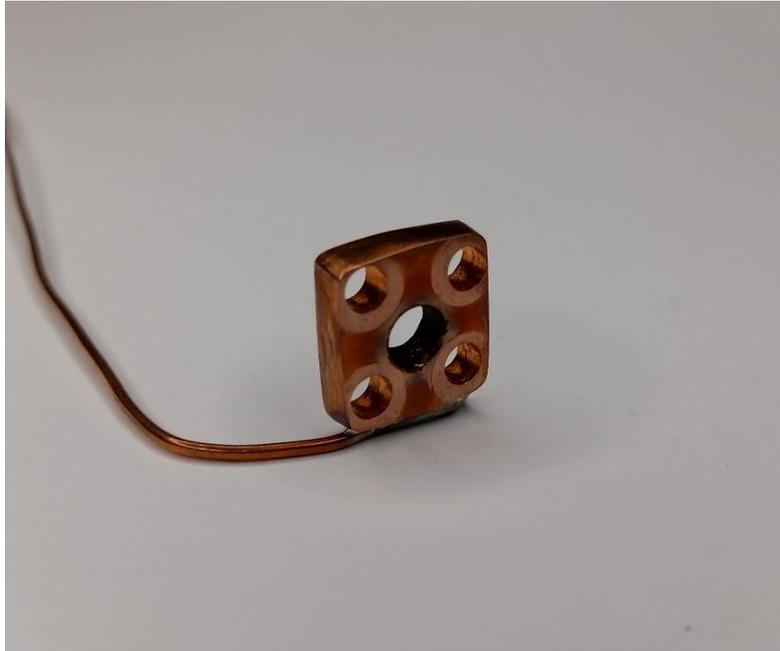
*FIGURE 2: Post testing anode*

Clear indication of fuel deposition both on the surface of the anode, as well as inside the anode bore can be observed. The areas where the PEEK bolt heads were located over the mounting holes can be seen to be deposit free compared to the rest of the surface. A close-up view of the bore can be seen in *Figure 3* below under a low-intensity optical microscope:

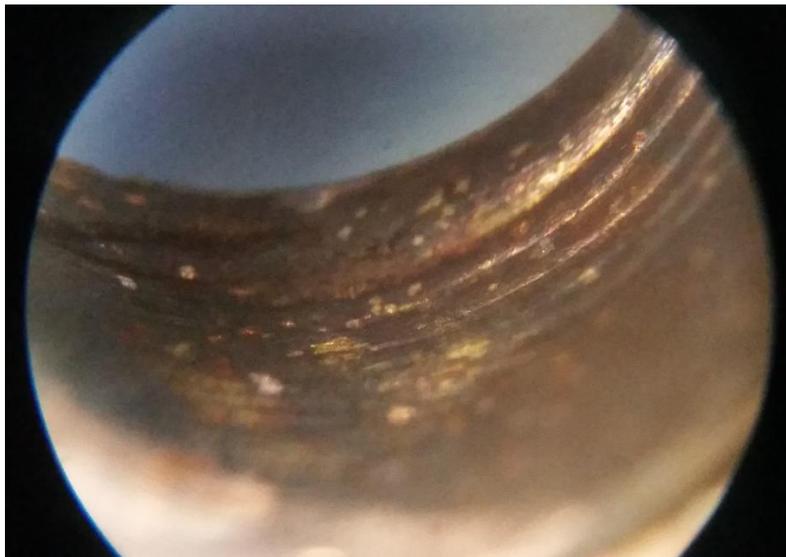
*FIGURE 3: Microscopic view of the anode surface*

There is again clear indication of fuel deposition buildup on the surface of the anode, which indicates carbon charring of the Teflon fuel. However, there appears to be minimal physical wear or erosion of the anode surface despite the main discharge and plasma interaction with the anode bore. The grooves around the face of the anode are from machining, and are not actual erosion. Around the surface, tiny lighter specs can be seen against the darkened surface, indicating arc attachment points from the main discharge. Overall, distribution looks fairly even and random in nature. There is currently no indication of measureable electrode wear for the anode over the course of 500 shots for the varying shot energies from 0.24J to 0.84J.

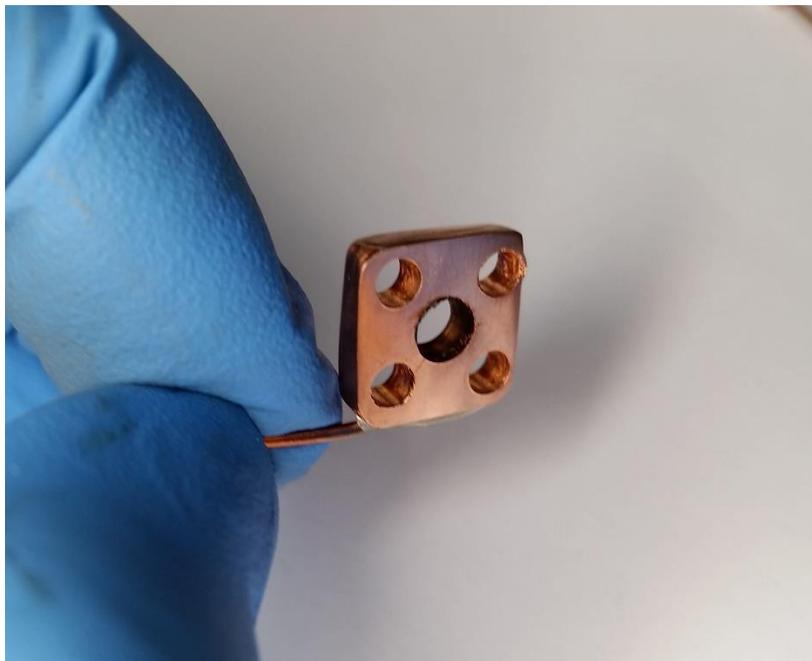
The second electrode of the thruster assembly, located in the center of the thruster stack, is the igniter. Initial visual inspection of the igniter bore surface indicates carbon deposition around the area of the bore directly under the Teflon fuel plate, with less discoloration towards the back. This carbonized ring around the upper part of the bore also coincides with the cathode pin edge where ignition would most likely occur.

*FIGURE 4: Igniter electrode post-testing*

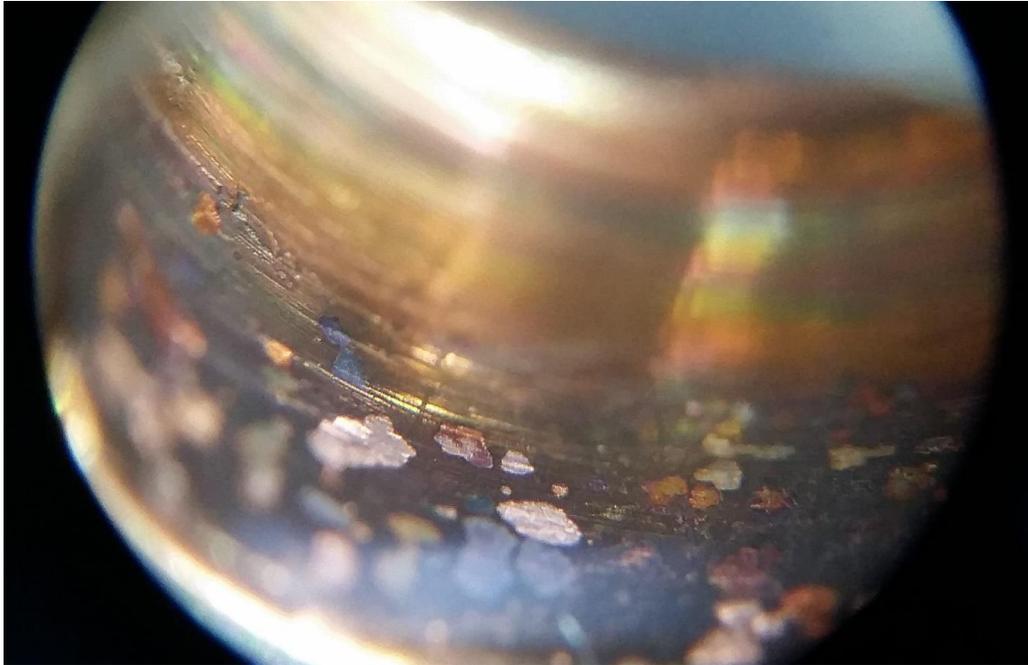
Inspection under the microscope confirms this, with much more carbon deposit and arcing spots towards the front of the bore. These arc spots are due to the ignition pulse between the igniter and cathode pin. The lack of arcs or carbon deposit towards the back half of the bore indicates little to no damage, arcing, or ablation around the Teflon cathode insulator plate.

**FIGURE 5:** *Microscopic view of the igniter surface*

Despite the arcing and carbon deposit, there is little indication of significant damage or erosion to the igniter bore that would impede performance.

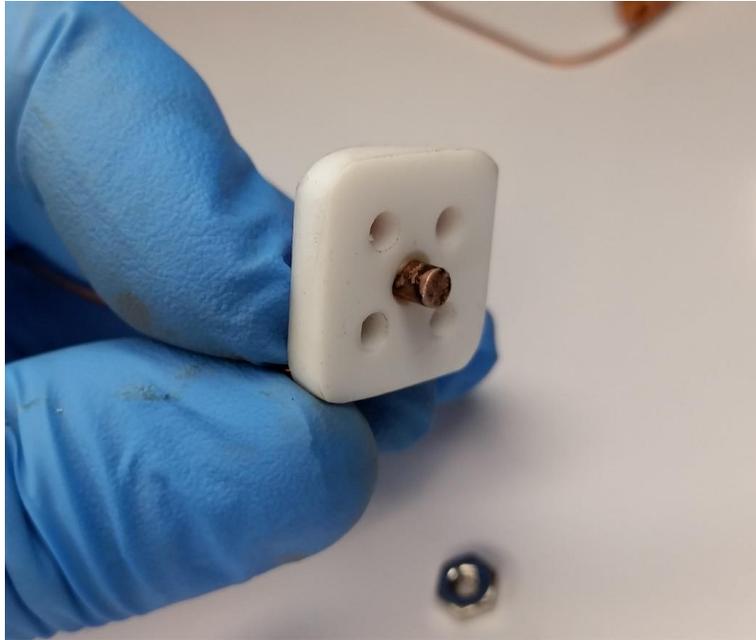
**FIGURE 6:** Cathode pin and Teflon cathode insulator after testing

While there is some evidence of wear and ablation on the Teflon insulating plate, damage is minimal, indicating that shorting failure at this stage of the thruster lifetime is not due to cathode-igniter insulation failure or charring.

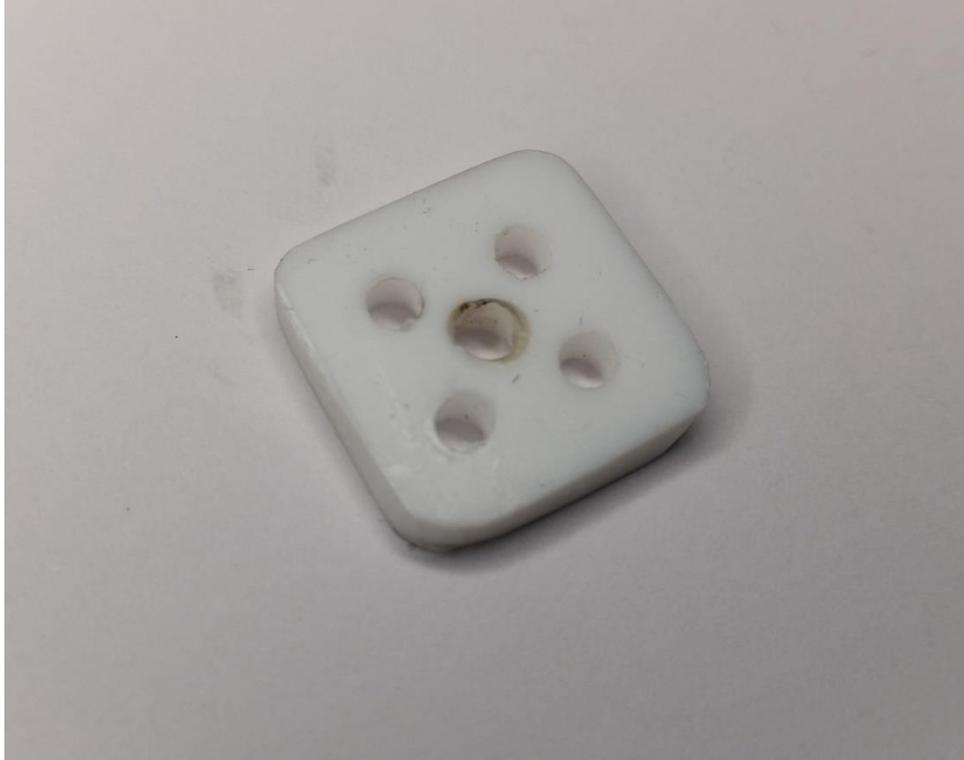
**FIGURE 7:** Teflon insulator after testing

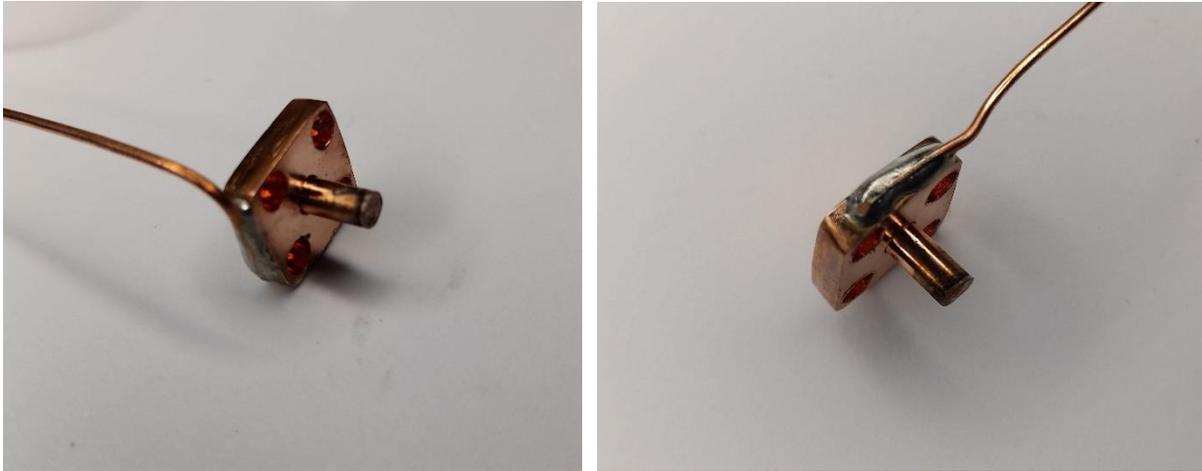
In Figure 8, the cathode electrode is separated from the insulator. A very clear ring of wear and carbon deposit can be observed around the circumference at the end of the cathode pin. Wear appears to be uniform around the cathode pin.

**FIGURE 8:** Cathode pin surface erosion after testing

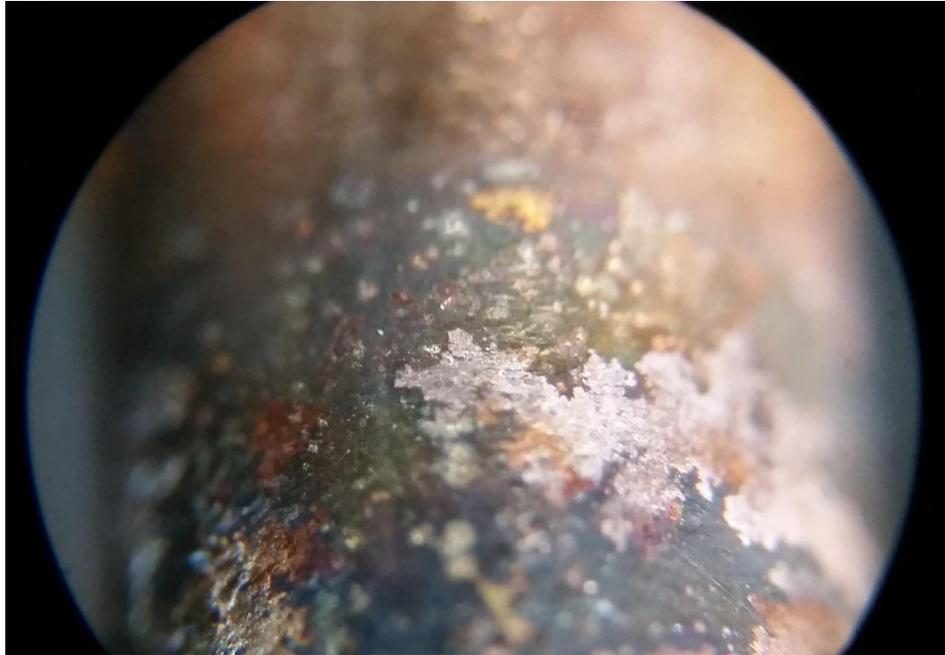
Upon closer inspection under the optical microscope, discoloration of the copper and evidence of arc spots is noticeable. However, like the previous two electrodes, actual erosion from thruster operation is minimal, and does not appear to play any factor in thruster lifetime at this stage of testing. In *Figure 9*, a portion of the igniter pin around the circumference at the end of the electrode is observed. Due to the low energy of the igniter pulse, erosion is kept minimal. In *Figure 10*, the end of the cathode pin is viewed. This portion of the pin is more directly exposed to the main discharge between the cathode and the anode, and is evident with the larger area of discoloration. Scratches on the surface are due to machining and are not part of the erosion process. Despite the main discharge and exposure to the plasma, no perceptible or measurable change in electrode dimensions were observed. Overall, uniform erosion around the edge for ignition, as well as at the flat tip has been confirmed for the limited shot lifetime of the thruster during prior phases of testing.

**FIGURE 9:** *Microscopic view of the circumference of the cathode pin surface erosion after testing*

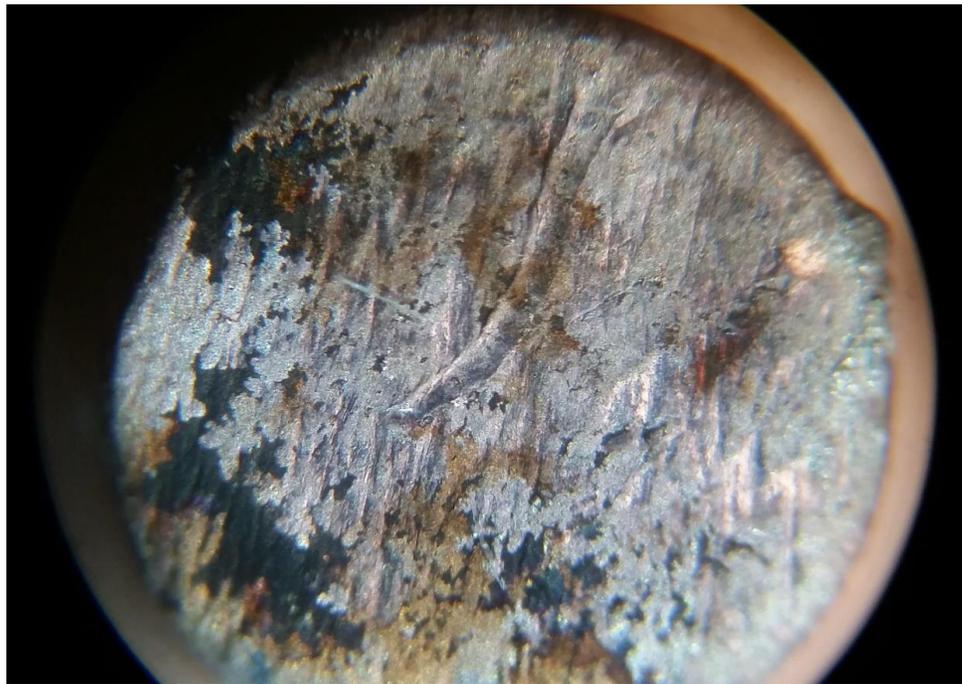
**FIGURE 10:** *Microscopic view of the end of the cathode pin surface after testing*

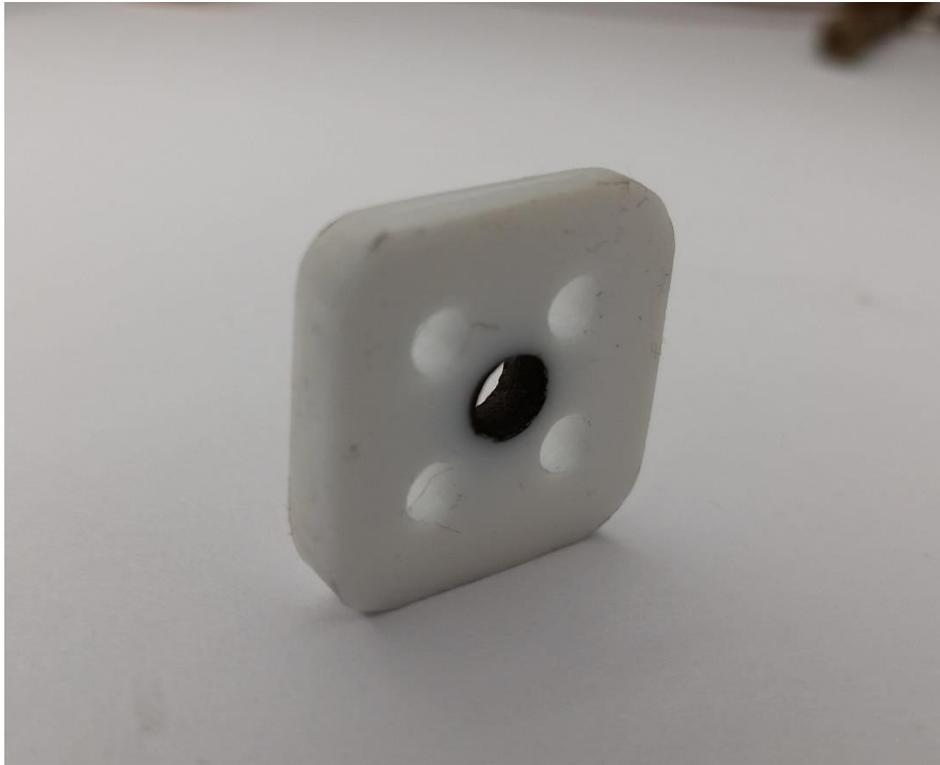
The final component of the thruster, and main area of interest, is the Teflon fuel plate. This plate is located between the middle igniter plate and the upper anode plate, and provides the source of fuel for the thruster. Upon disassembly, it was immediately evident that the fuel bore suffered severe charring at the surface. This can explain the carbon deposits on the various other electrodes prior discussed. *Figure 11* depicts the Teflon fuel bore after 500 shots in the thruster.

**FIGURE 11:** *Teflon fuel with severely charred bore after testing*

- The cause of failure of the thruster, ultimately limiting its lifetime to 500 shots, was a result of charring of the Teflon fuel, causing eventual misfires and shorting of the thruster.

Going forward, the key issue to be addressed is charring of the Teflon fuel. Based on the Teflon fuel bore starting surface area of  $0.38 \text{ cm}^2$ , and a maximum tested discharge energy of  $0.84 \text{ J}$ , the maximum energy density on the fuel surface is  $2.22 \text{ J/cm}^2$ . Due to operation of this low-energy, sub-joule, coaxial pulsed plasma thruster in electrothermal mode, it is expected that the energy density on the Teflon fuel was excessive, causing significant charring of the fuel, resulting in radically shortened lifetime. This may be further exacerbated by the unusually short discharge length and aspect ratio of this particular thruster, due to space constraints for use with PocketQube-class satellites for which this thruster was designed for. Areas to explore to mitigate these effects include changing the fuel bore aspect ratio, decreasing the energy per shot for this configuration, exploring other fuels, and ultimately optimizing the energy density on the fuel surface to provide enough ablation for reasonable thrust while being low enough to prevent carbon charring of the Teflon.

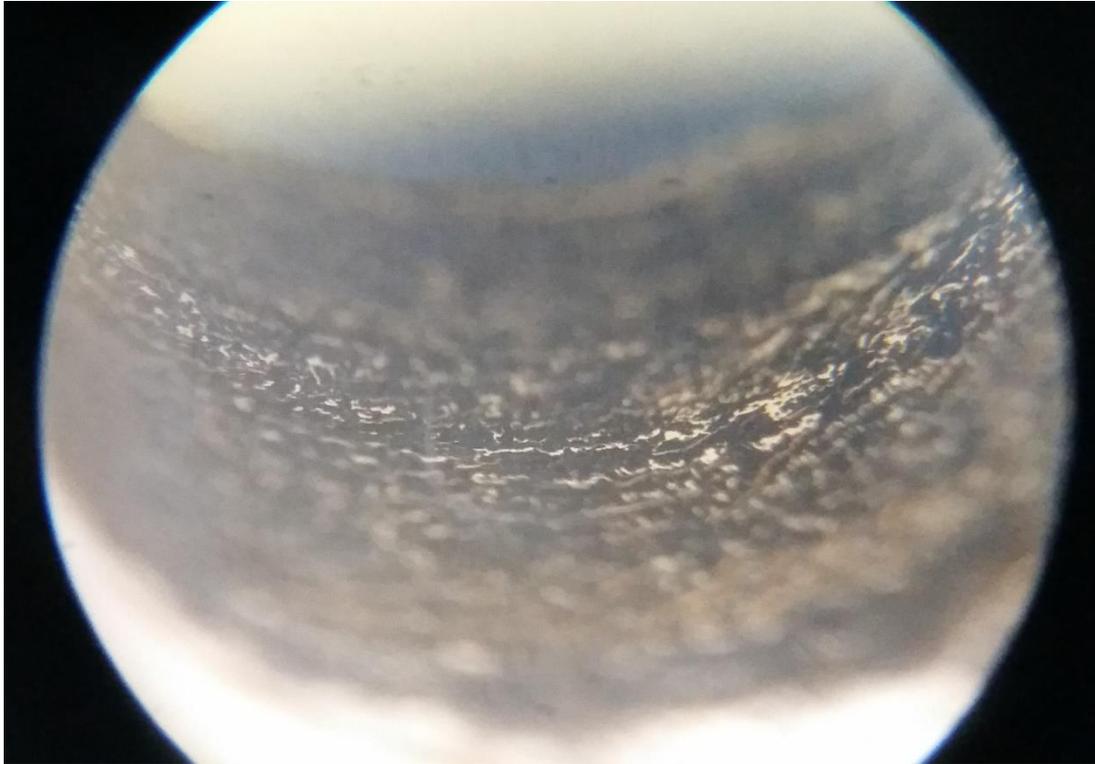
Upon further inspection under the microscope, a clear picture of very uniform charring and wear is evident along the surface of the fuel bore. Measuring the bore with calipers, there appeared to be no measurable deviation in bore diameter from the original starting diameter of 0.15". During testing, towards the end of life of the thruster, it was observed that the thruster would break down randomly regardless of the ignition pulse. It can therefore be inferred that the cause of failure of the thruster over its 500 shot lifetime is due purely to charring of the Teflon fuel, causing the thruster to eventually short, as opposed to any electrode erosion or fuel depletion.

**FIGURE 12:** *Microscopic view of the Teflon fuel bore after testing*

- Uniform wear and charring of the Teflon fuel bore was observed, with no measurable changes in diameter over its lifetime. Therefore, it can be inferred that lifetime based on fuel usage is significantly higher than lifetime limits from charring.
