Applied Ion Systems

AIS-TR-010

AIS-ILIS1 Ionic Liquid Ion Source Electrospray Thruster V4

Fueling and Ignition Test 1 - 07/04/2020

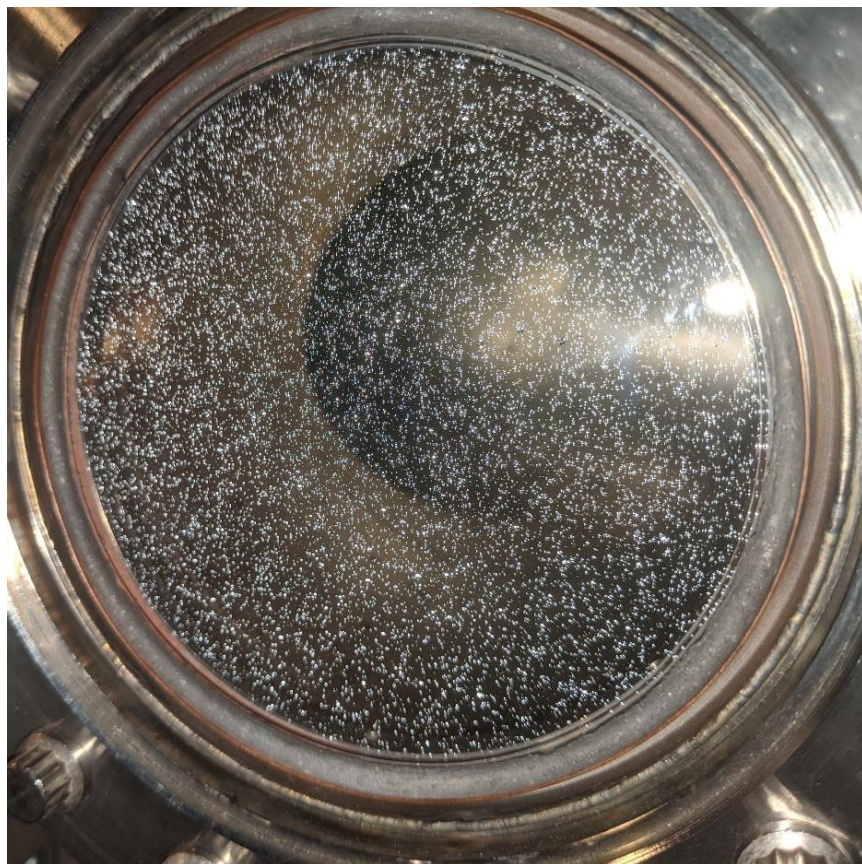
FIGURE 4: *EMI-BF₄ chamber contamination during first fueling attempt*

Upon inspection, it was found that significant contamination of the chamber occurred, with a large amount of the ionic liquid fuel depositing inside the chamber. Fuel did not make it into the main diffusion chamber however, and the system was thoroughly cleaned using wipes, acetone, and isopropyl.

Originally it was thought the fuel spraying was due to the sudden pressure change from atmosphere to vacuum due to opening the isolation valve from the roughing line to the main chamber. The fueling station was therefore refilled, and pumpdown started again, this time with the roughing isolation valve barely opened to choke pumping speed to slowly bring down pressure in a more controlled manner.

Pumpdown was started again. This time, violent bubbling was noticed from the bulk liquid, with significant splashing inside the jar. Due to the high concentration of absorbed gases and water vapor in the ionic fuel, the liquid spray prior observed was in fact due to the degassing process. Severe degassing continued into the low milli-Torr range during the roughing cycle of pumping. However, no liquid spray was further observed in the chamber. The high vacuum pump was turned on, and the fuel and glass structures were allowed to continue to degas and saturate in high vacuum for several hours, until an ultimate pressure of 8×10^{-6} Torr was achieved. With this, adequate degassing of the fuel, as well as saturation of both porous glass structures were successfully achieved. The system was shut down, and preparations were made for the Phase II ignition test attempt.

- Fueling must occur in vacuum for full saturation of the porous glass structures
- Fueling must be done in an enclosed container to prevent fuel spray and chamber contamination during degassing
- Degassing of the fuel and porous emitters is crucial for proper thruster preparation
- Emission conditioning is needed prior to full power operation
- Faster cycle times is much more challenging for stability
- Extractor aperture must be as small as possible to reduce turn-on voltage level and subsequent ionization while minimizing liquid bridging.
- Outgassing from the plastic housing can cause ionization faults in the housing.

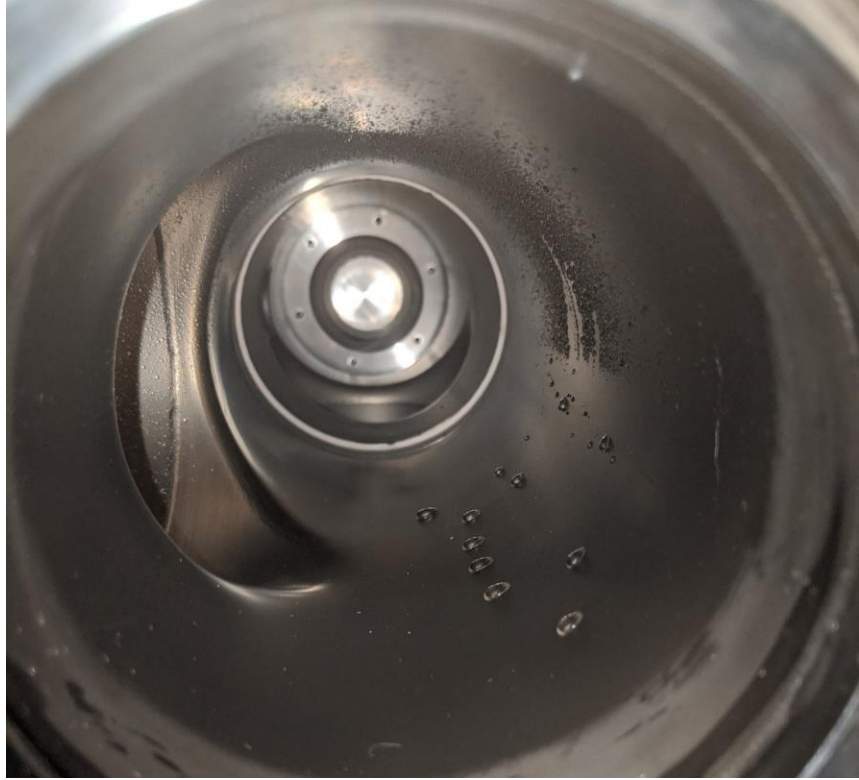
FIGURE 5: *EMI-BF4 chamber contamination*

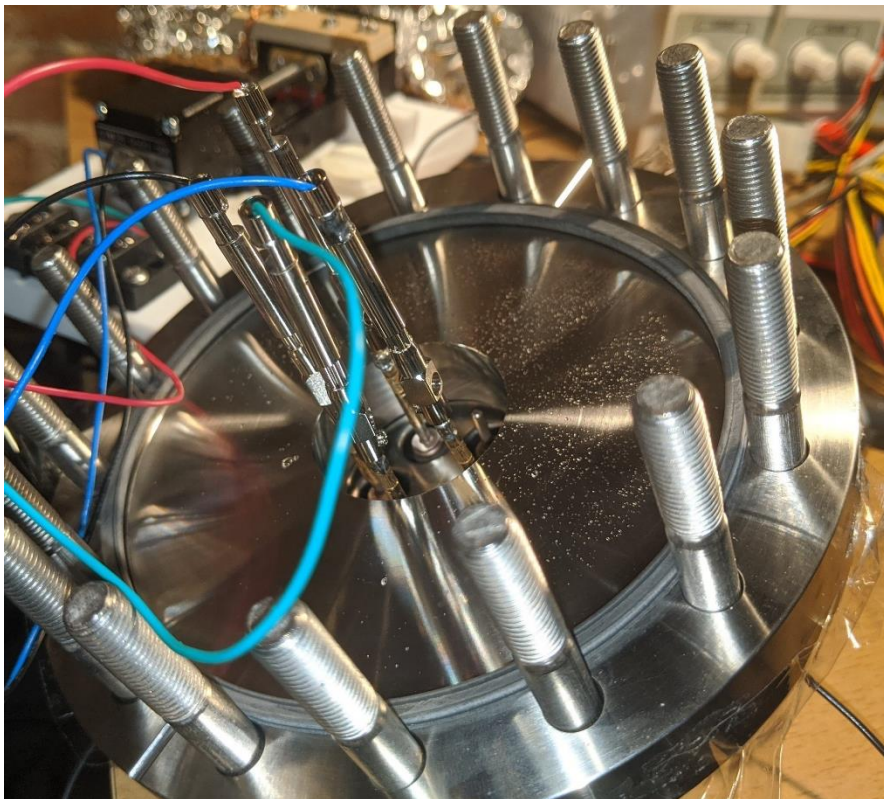
FIGURE 6: *EMI-BF4 contamination of chamber feedthrough*

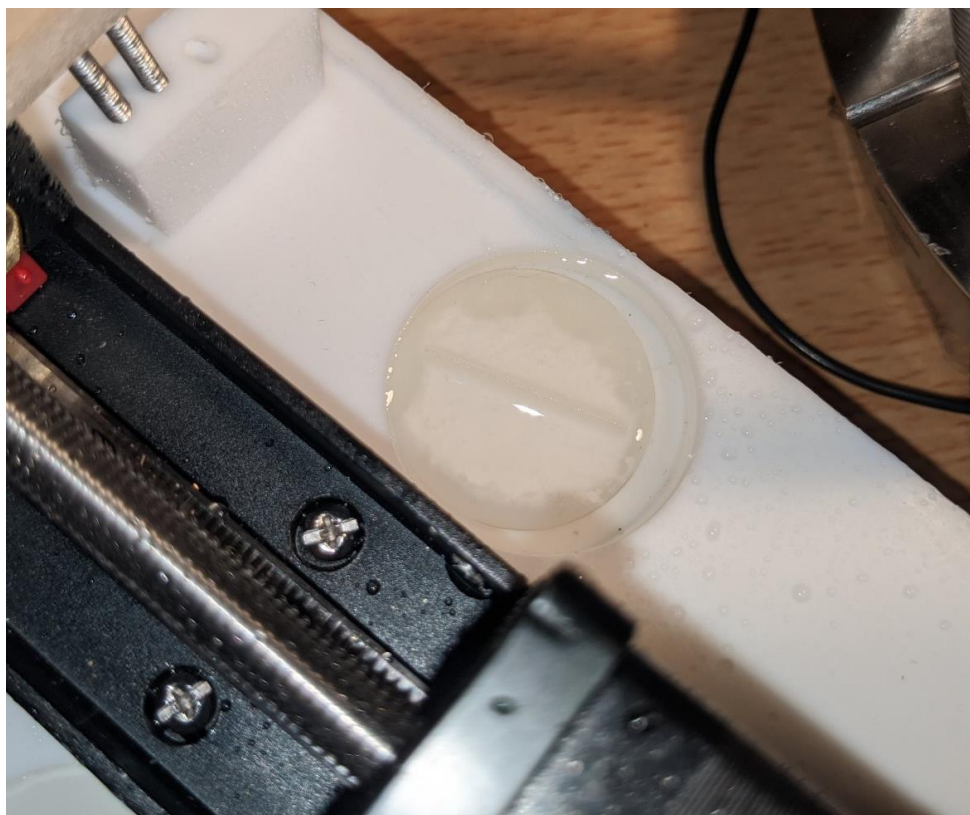
While the larger pores of the reservoir filled without issue, it was immediately apparent that the smaller pores of the emitter were not saturating properly. The EMI-BF₄ ionic liquid is quite viscous, and the central part of the glass emitter was not wicking up the liquid. This confirmed that the glass structures must be saturated in vacuum to achieve complete filling of the glass pores with the fuel.

FIGURE 9: Incomplete saturation of the emitter with EMI-BF₄ in atmosphere

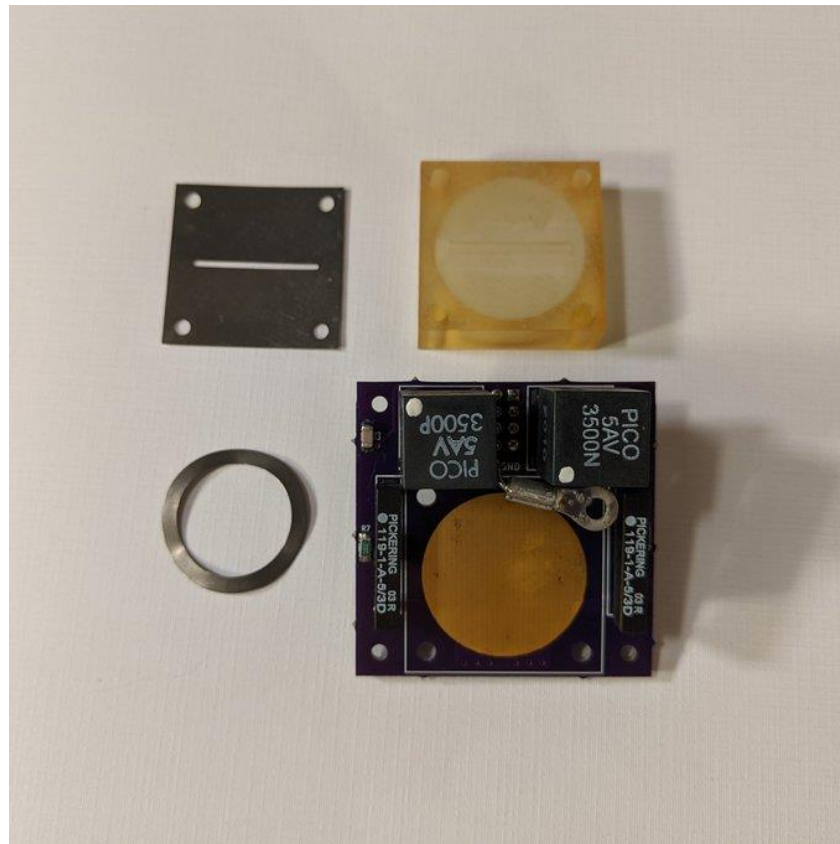
Upon disassembly of the thruster, no signs of arcing damage on the emitter, extractor, or circuit board were found. In addition, no liquid droplet spray or deposits were found between the emitter and extractor, and no fuel leak was observed on the board or inside of the casing.

FIGURE 17: *ILIS1 disassembly post ignition testing*

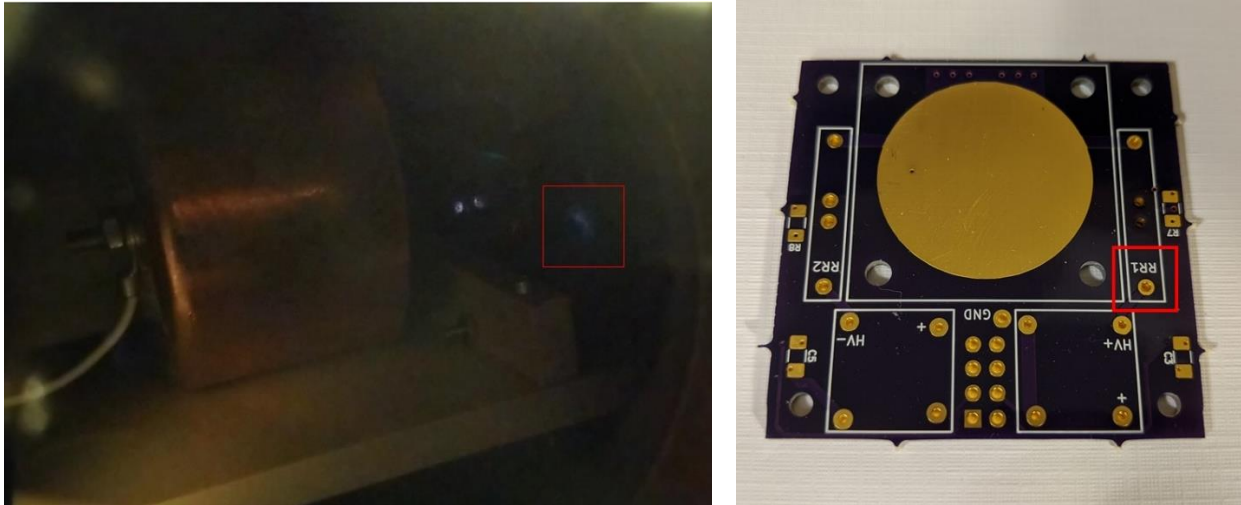
During the test, numerous board faults were observed. There are two key areas identified on the board, both around the +HV relay. The first of these occurs on the front of the board at the +HV relay input. The diffuse glow shows that this is not an arc, but ionization of some outgassing product.

FIGURE 18 AND 19: Ionization fault on board front near +HV relay input pin (LEFT), location of ionization fault on board (RIGHT)

For the thruster PCB, all silkscreen should be minimized, if not fully eliminated from the PCB. All high voltage through-hole components such as the relay pins and power supply pins should be ground down smooth to the board to minimize field enhancement at sharp points. The thruster and all components, especially the housing, should be baked and degassed for several hours at reasonable temperatures. The thruster should also be baked a second time during pumpdown before ignition.

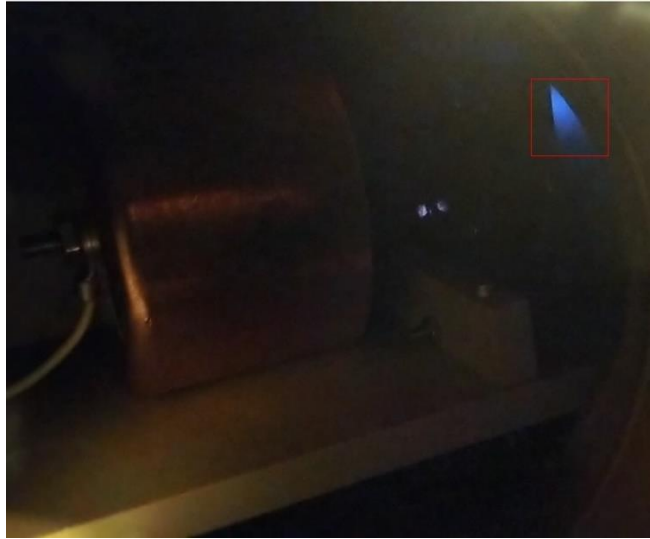
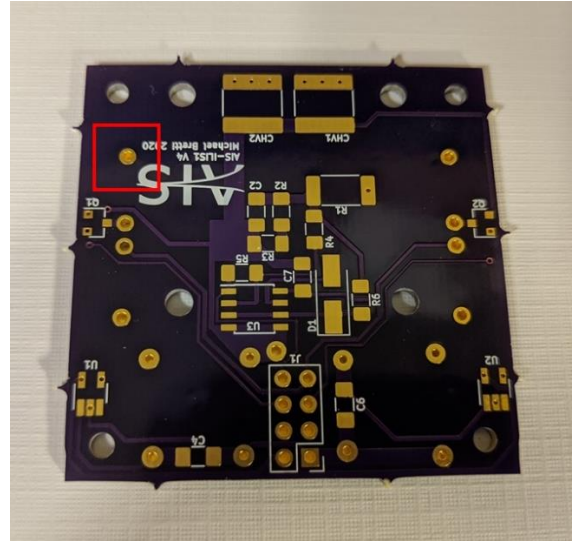
The second noticeable board fault occurs on the back near the +HV relay output. Here it can be observed that a much larger diffuse emission happens. Both of these board faults were seen numerous times, consistent in location and intensity. In both cases, there is a noticeable amount of silkscreen near these HV points. Since there was no arcing damage on the board, it is clear that no tracking faults occurred. However, based on the diffuse nature of the fault, it appears more like ionization of gas, which is most likely outgassing products from the silkscreen being ionized by sharp HV points on the board near the switching inputs and outputs of the HV relays.

FIGURE 20 AND 21: Ionization fault on board back near +HV relay output pin (LEFT), location of ionization fault on board (RIGHT)

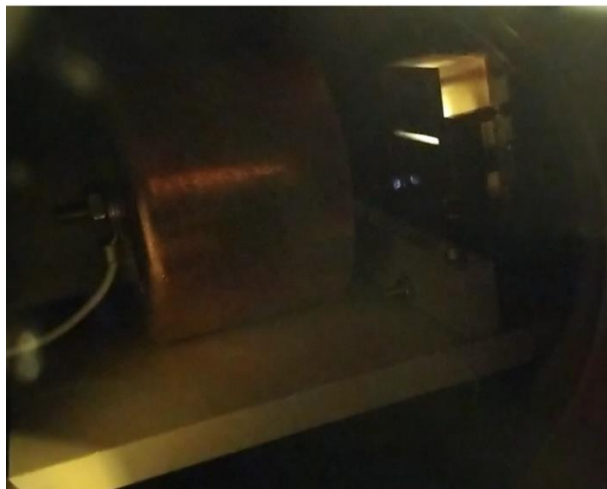
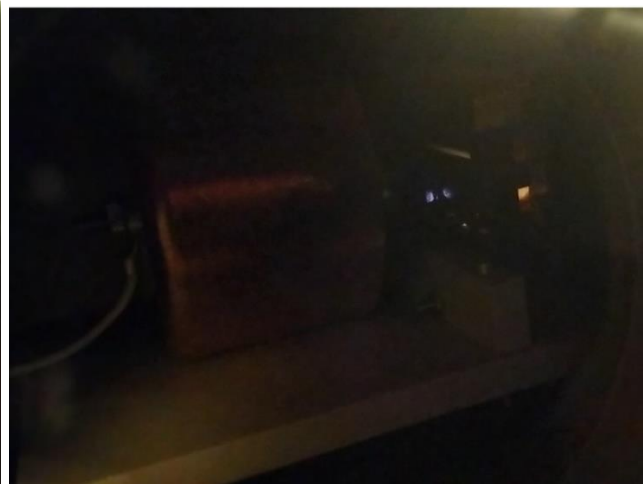
A third and unusual fault was noticed inside of the thruster casing itself. This was characterized by an orange glow within the casing, but no observable emission. This was seen numerous times near the emitter at the top as well as near the contact at the rear of the case. It is strongly suspected that outgassing products from the 3D resin printed case, which is a SLA print using Accura 48HTR resin of unknown vacuum compatibility, was playing a role in this spurious internal ionization.

FIGURE 22 AND 23: Internal ionization faults in 3D printed thruster housing

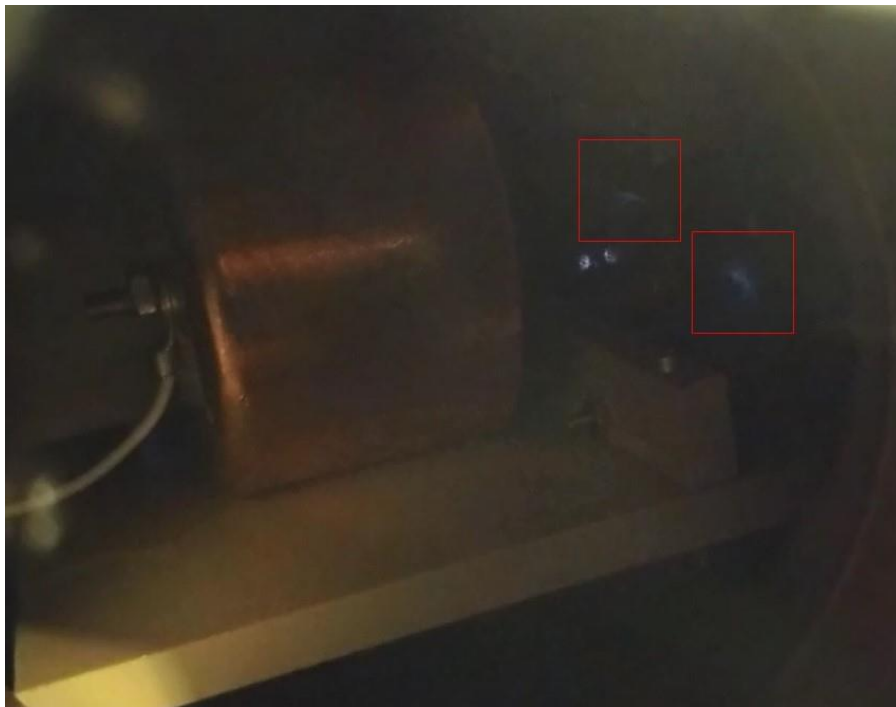
In several instances, a transition from emission to board fault can be observed, where emission first starts, but later dies out due to the board fault occurring. We can see this happening on both the front and back board faults identified earlier.

FIGURE 27: *Captured transition from partial ion beam emission to front board fault*

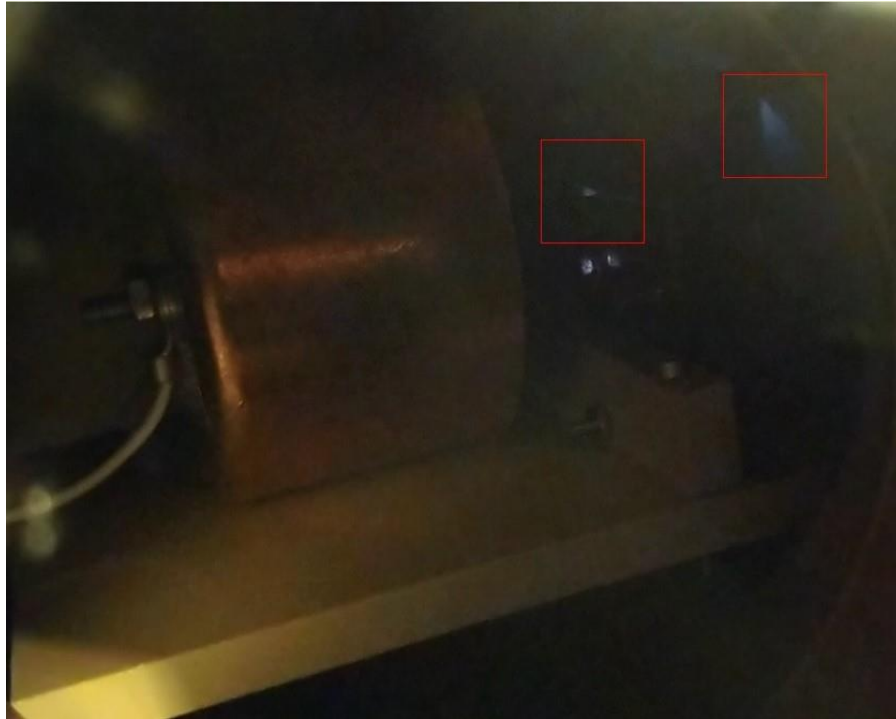
FIGURE 28: *Captured transition from partial ion beam emission to back board fault*
