Applied Ion Systems

AIS-TR-008

AIS-gPPT3-1C Integrated Propulsion Module V3 Phase III - Lifetime Testing - 09/30/2019-10/03/2019 Testing Report and Summary Michael Bretti – 03/04/2020

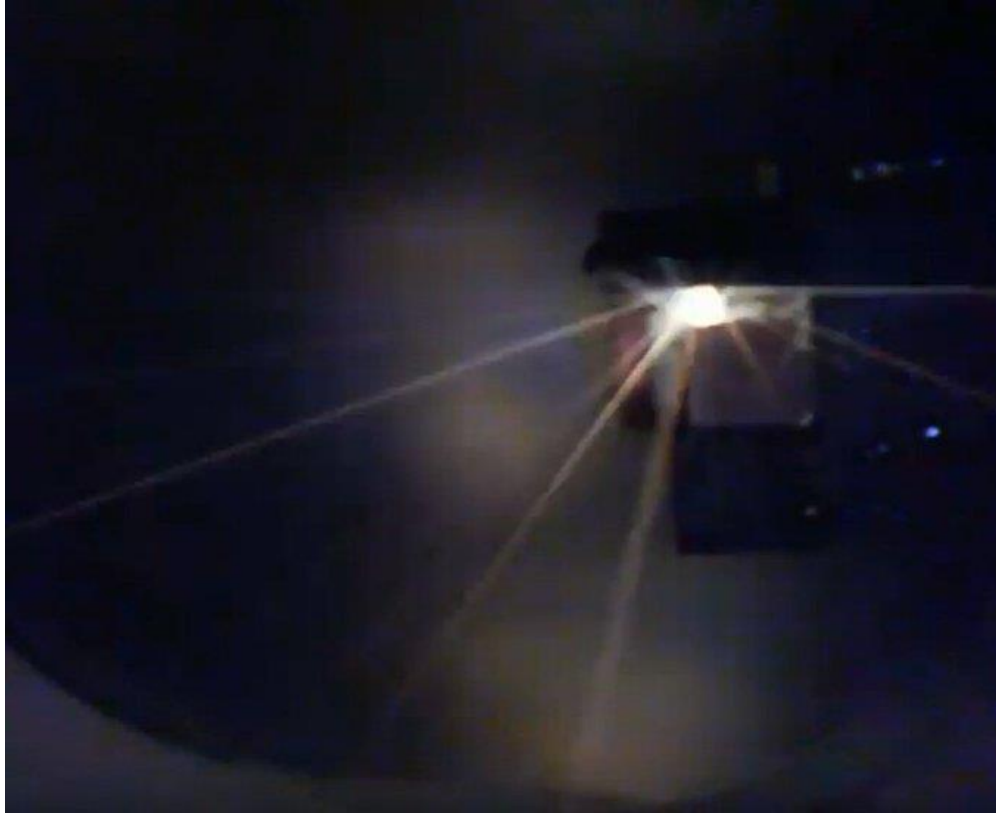
FIGURE 7: Catastrophic failure of the primary pulse capacitor bank during round 1 lifetime testing.

Unfortunately, this increase in output voltage resulted in overdriving the pulse caps, despite very stable operation. Peak pulse capacitor voltage was at 2kV, resulting in a total bank energy of 0.27J. The test was terminated when one of the main pulse caps failed catastrophically, blowing out debris from the side of the casing. Although the capacitors are rated for a peak of 2kV, nominal operation is only around 1kV. *Figure 7* shows the captured failure during the end of testing. *Figure 8* shows close-up analysis of the failed pulse capacitor.

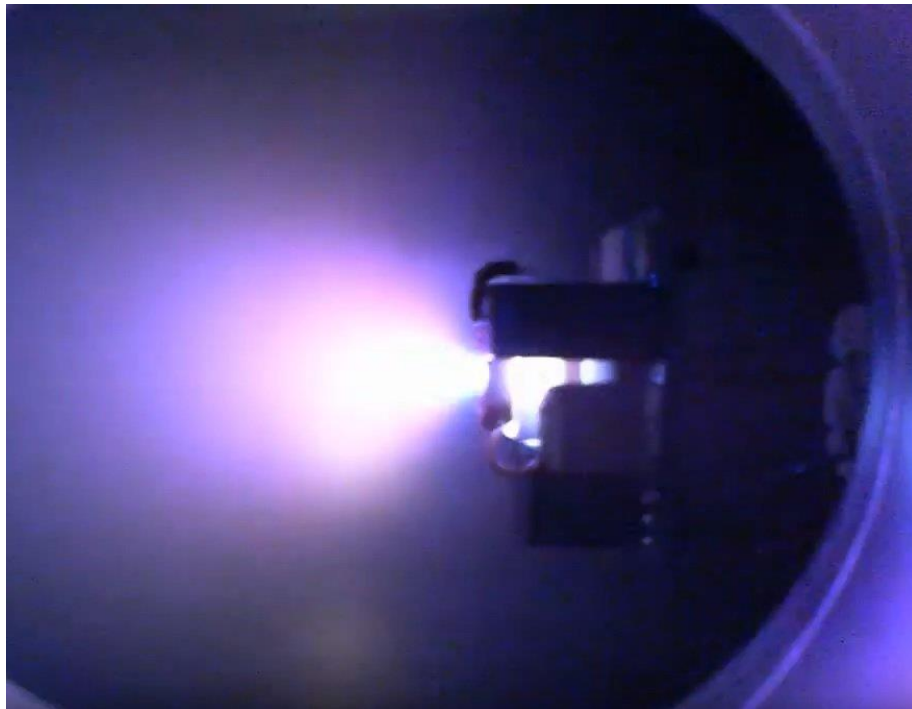
FIGURE 9: AIS-gPPT3-1C plasma plume recorded from webcam during livestream of round 2 lifetime testing.

The thruster successfully completed 5.33 15 minute orbital firing cycles with 5 minute cooldowns in between, before the main bank shorted and failed. The repetition rate was between 0.29-0.33 Hz for each 15 minute cycle duration. The input voltage was kept at 4V for the duration of the test. Figure 9 shows an example of the captured plasma plume during round 2 of lifetime testing from the webcam livestream.
