AIS-TR-012

AIS-ILIS1 Ionic Liquid Ion Source Electropray Thruster V6

Fueling and Ignition Test 3 - 08/16/2020

Testing Report and Summary

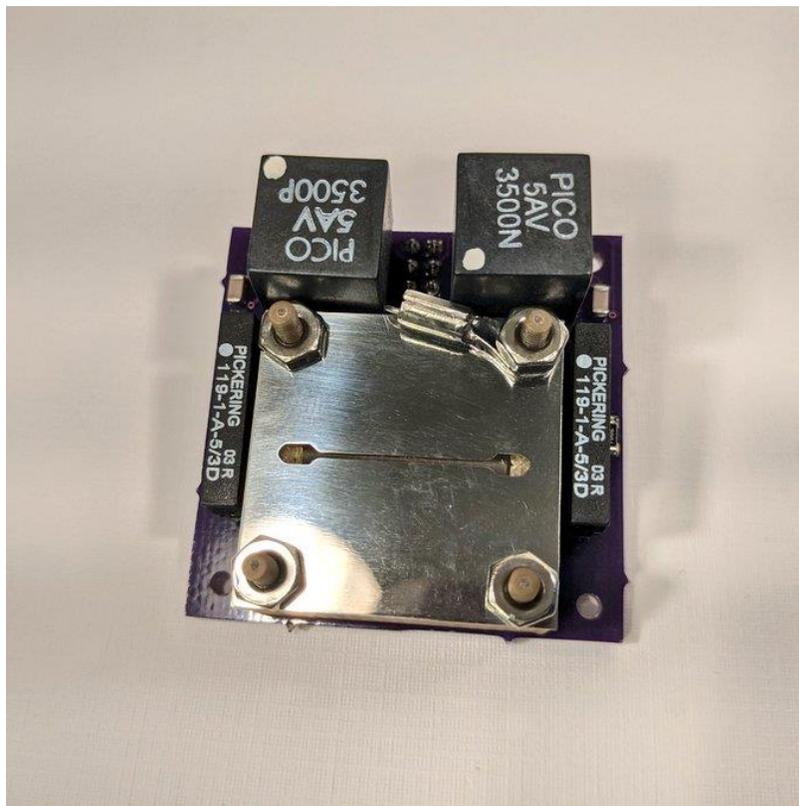
FIGURE 1: Completed AIS-ILIS1 V6 thruster assembly

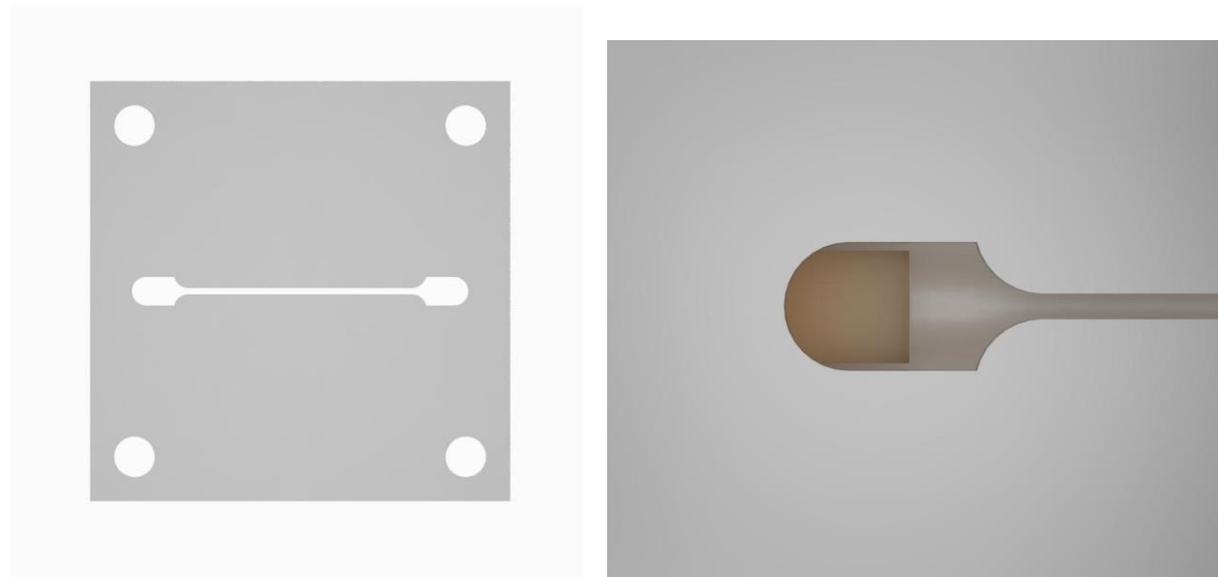
During prior testing of the ILIS1, it was found that emission would concentrate at the corners or the ridge emitter, rather than along the length of the ridge itself. Due to the sharp edge, higher field enhancement results at the corner, causing early turn-on, as well as excessive emission concentration at this area. In order to reduce field enhancement at the corners, and achieve more uniform field distribution along the length of the ridge, a modified, enhanced extractor geometry was developed. Instead of a linear slit which is traditional for ridge or slit based electro spray, the last several mm at each end was flared out significantly, in addition to the central region of the slit being reduced further in width.

FIGURE 2 & 3: Enhanced extractor design with flared edges (LEFT), flare geometry and emitter alignment close-up (RIGHT)

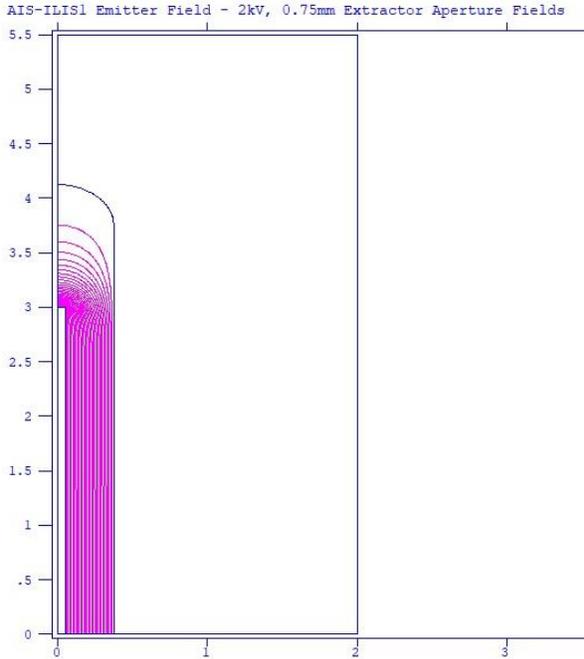
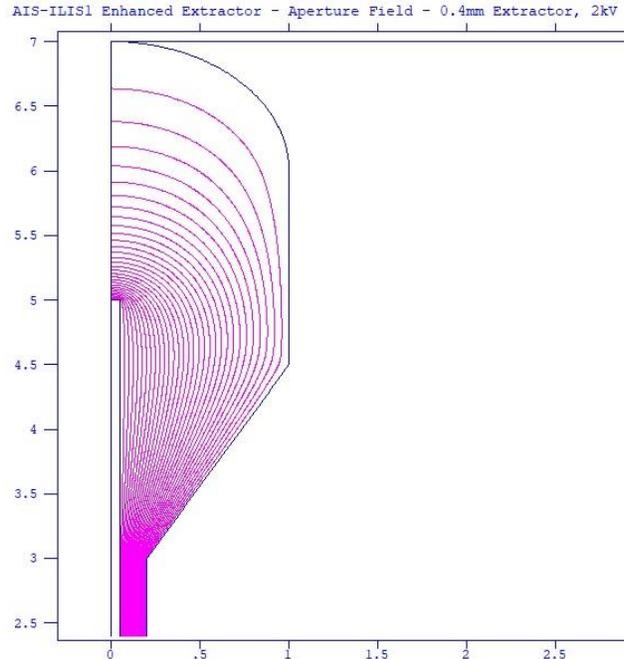
Electrostatic field simulation results show that field enhancement is significantly reduced at the corner, with the main portion of the ridge having much higher field strength. Although there is some higher field strength at the edge still, it remains lower than the central region at all times, eliminating early turn-on at the edges and forcing emission to occur across the bulk of the slit.

FIGURE 4 & 5: Prior extractor design field strength (LEFT), enhanced extractor design field strength (RIGHT)

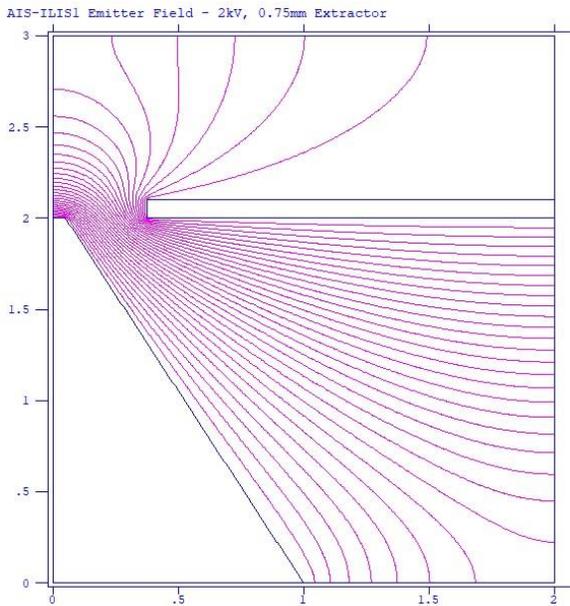
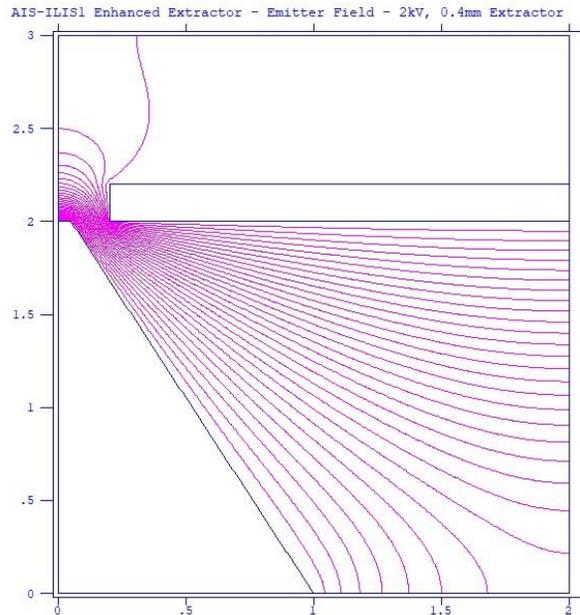
In addition, a slightly thicker extractor plate was used, at 250um vs the original 100um. Field simulations show reduced field divergence as a result, which translates to reduced beam divergence. The thinner slit aperture also serves to further increased field strength at the ridge emitter, with the aim to cause emission to start at lower voltages.

FIGURE 6 & 7: Prior extractor design field strength cross-sectional view (LEFT), enhanced extractor design field strength cross-sectional view (RIGHT)

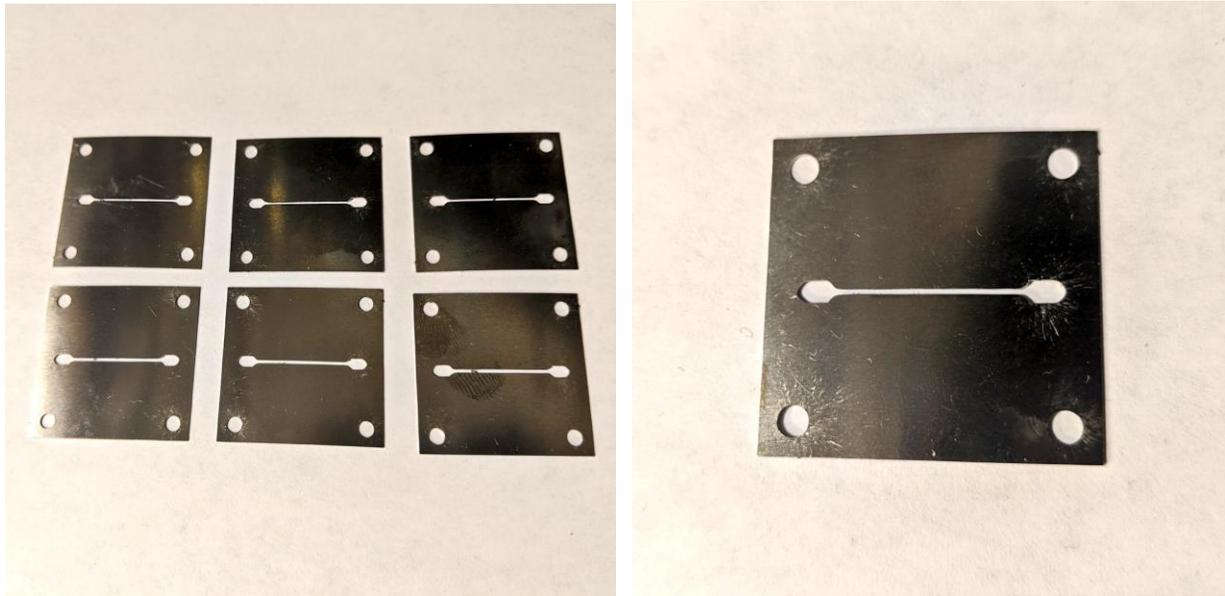
The final extractors were fabricated from 250um spring-temper stainless steel sheet. Three sets of both 400um and 500um width apertures were made.

FIGURE 8 & 9: Enhanced extractor sets, 0.4mm top, 0.5mm bottom (LEFT), enhanced extractor (RIGHT)

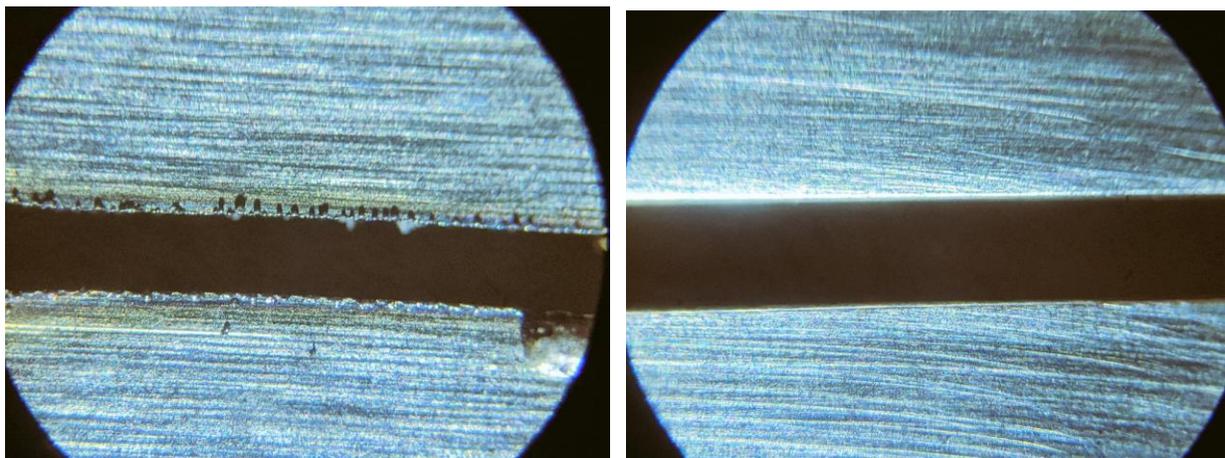
Upon arrival and inspection of the new extractors, it was discovered that the laser cut edges were of extremely poor quality, exhibiting significant dross, unevenness, burrs, and charring. The edges were manually cleaned and polished using 3000 grit sandpaper, and both faces of the extractor were polished with 3000 grit sandpaper as well.

FIGURE 10 & 11: Microscope view of extractor slit upon arrival (LEFT), extractor slit post-processing (RIGHT)

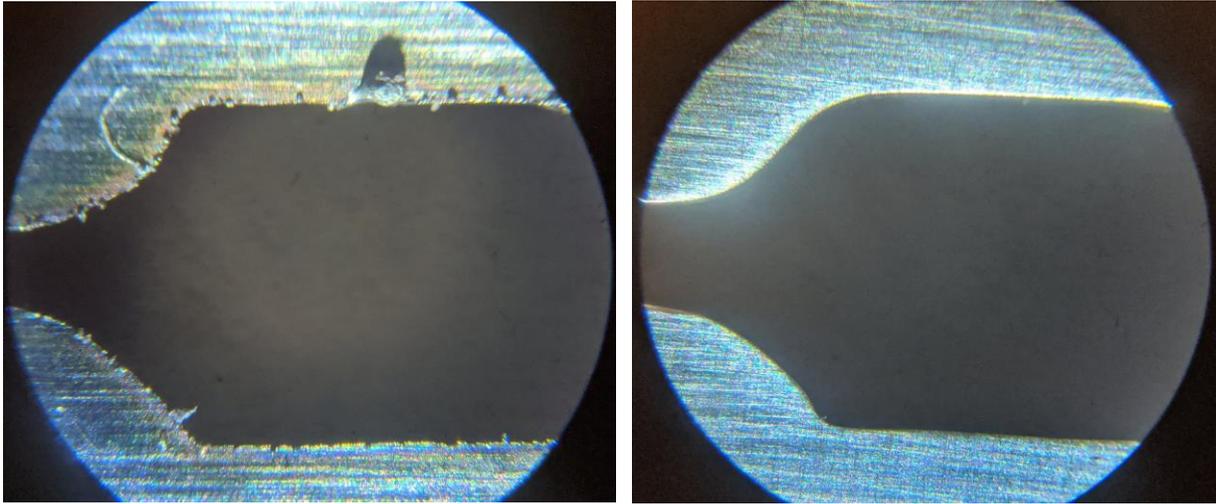
FIGURE 12 & 13: *Microscope view of extractor slit end flare upon arrival (LEFT), extractor slit end flare post-processing (RIGHT)*

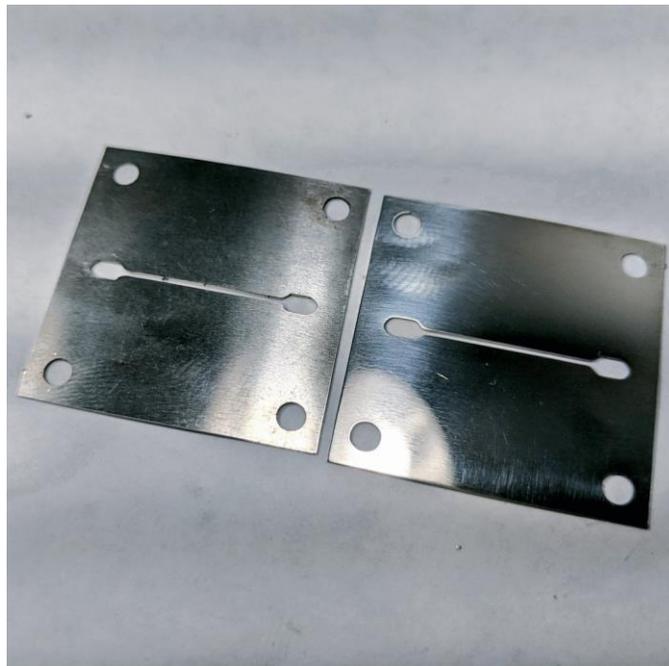
FIGURE 14: *Comparison of original (left) and polished (right) extractors*

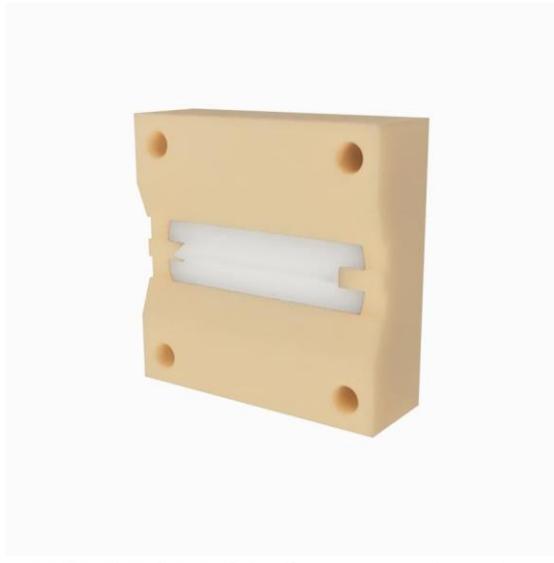
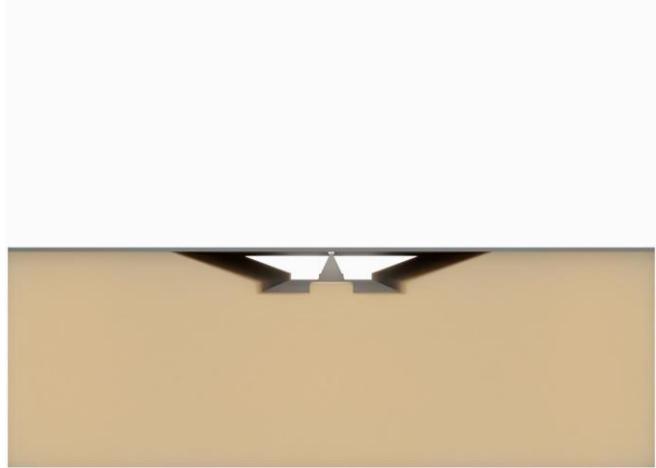
During the prior test, the thruster eventually shorted due to charring of the fuel caused by liquid creep along the 3D printed Ultem 1010 housing between the emitter and extractor. As a result, the 3D printed thruster housing design was modified to minimize plastic around the ridge to prevent direct liquid creep along the surface, which would cause shorting over time. Small tabs were created on the very ends of the ridge emitter for positioning and alignment of the ridge.

FIGURE 15 & 16: Concept design of the enhanced thruster housing with emitter (LEFT), side view of thruster housing with emitter and extractor alignment (RIGHT)

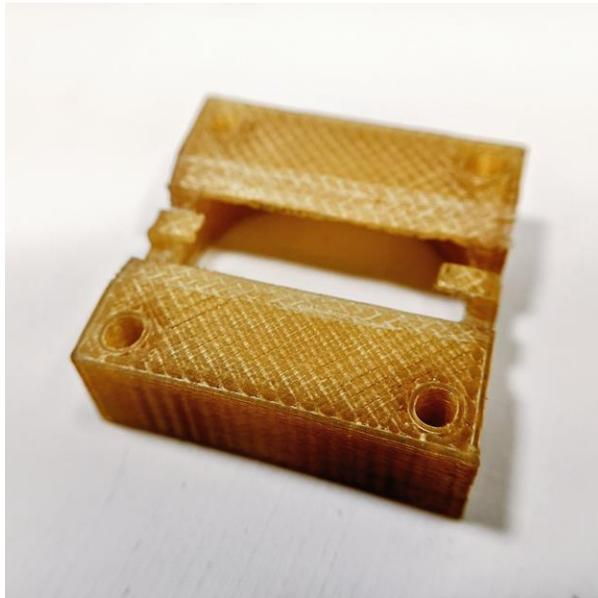
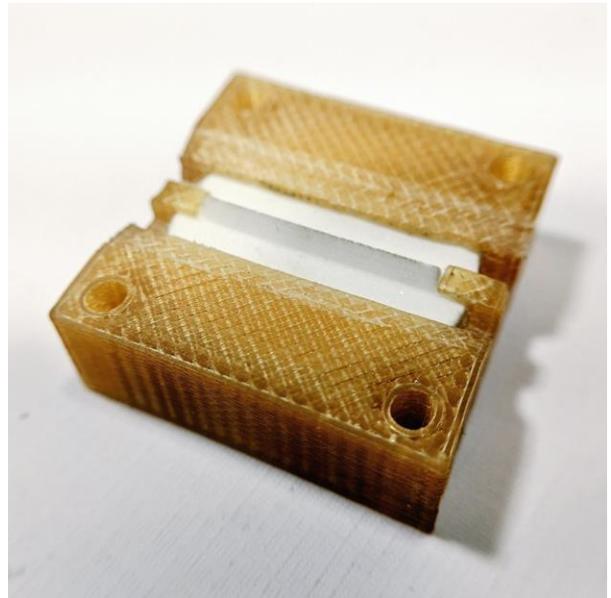
FIGURE 17 & 18: Modified 3D printed Ultem 1010 housing (LEFT), housing with emitter for test fit and alignment (RIGHT)

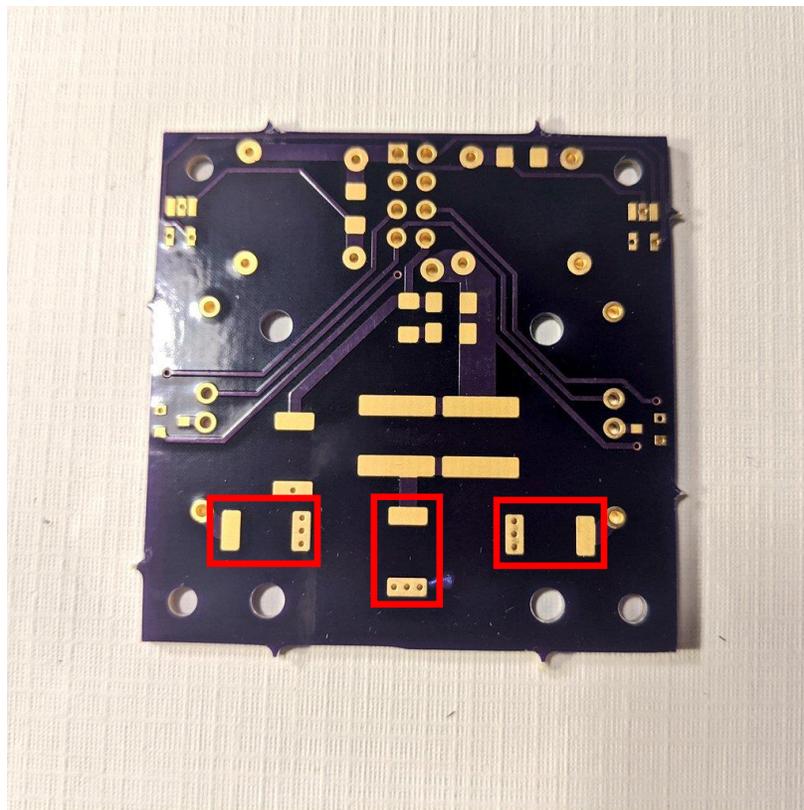
Finally, the thruster circuit boards were modified to include additional surge protection resistors to limit arcing current, and subsequent thruster damage due to breakdowns during operation. 100k resistors were placed between the output of the HV isolation relays and the emitter contact pad, and between the HV filter capacitor and the emitter contact pad. In addition, a 100k resistor was placed between the extractor plate and ground, further reducing surge currents, as well as allowing for beam intercept current on the extractor for future tests. Due to these changes, the high voltage divider readout was slightly modified to compensate for these changes to provide accurate readings, which was tested against the ILIS1 HV test load.

FIGURE 19: New V6 PCB design with 100k HV SMT surge protection resistors (outlined in red boxes)

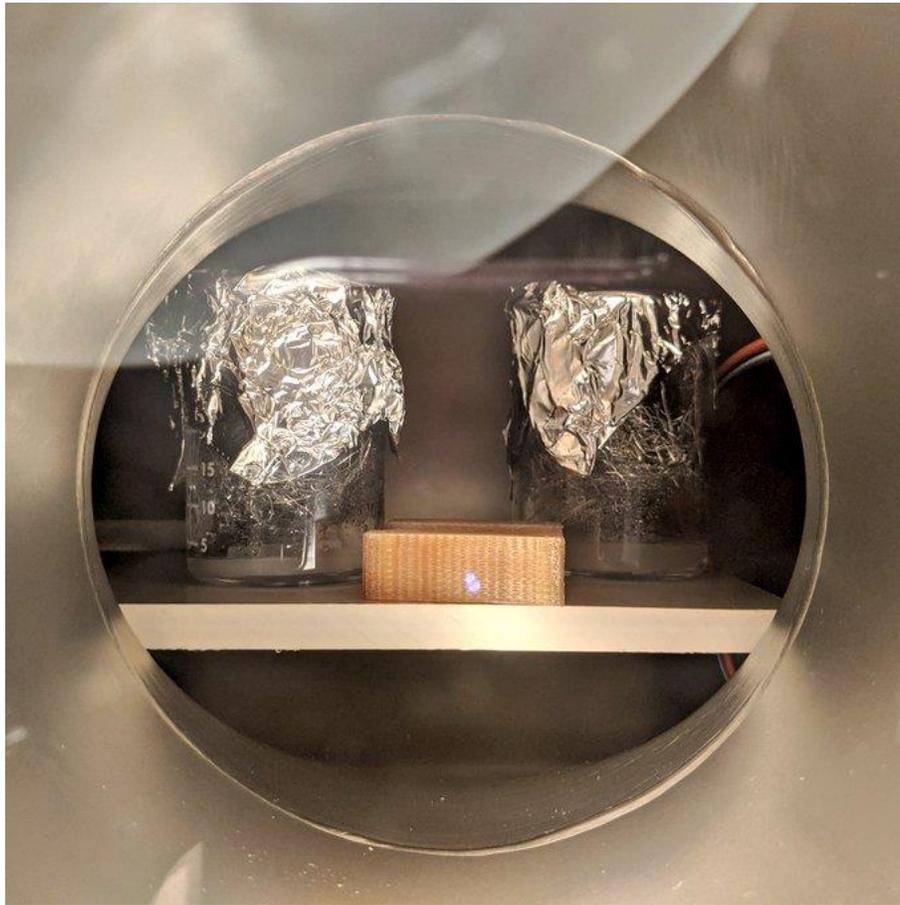
The filled beakers, Ultem printed housing, and vacuum thermocouple, were mounted on a scrap PEEK baseplate that rested inside the chamber, to prevent direct heating from the chamber during bakeout. The system was pre-pumped with the roughing pump the night prior and sealed to facilitate faster pumpdown during the fueling phase of the test.

FIGURE 20: Saturated porous glass emitter and reservoir with Ultem housing on PEEK baseplate for baking and degassing

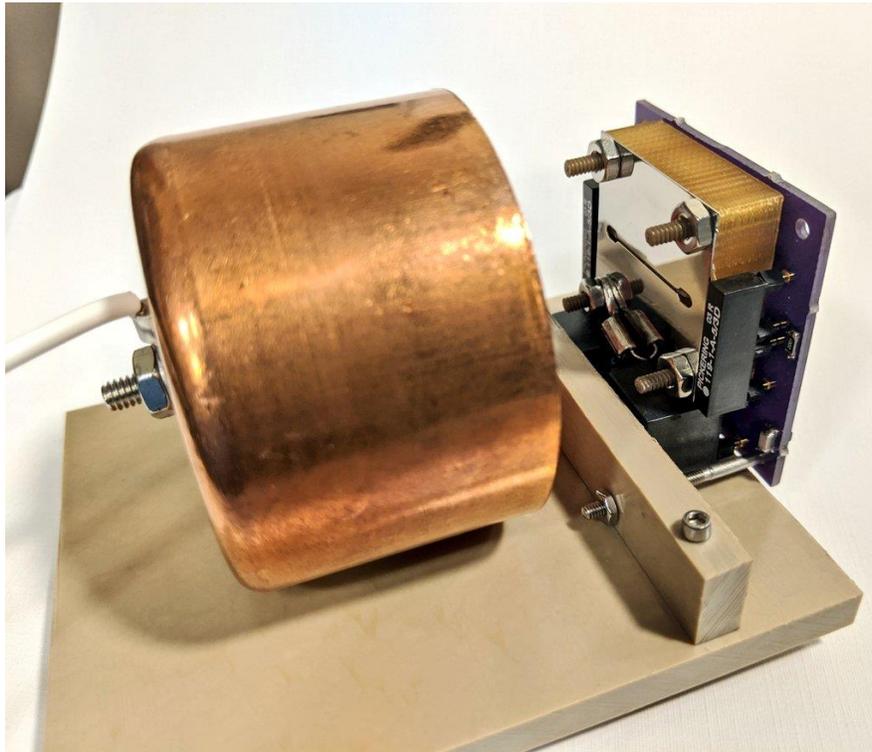
After fueling was completed, final assembly and system preparations were made for the next phase of ignition testing. The thruster components were cleaned, and with the fully loaded emitter and reservoir, assembled into the final thruster. The thruster was then mounted to the Faraday cup test stand, which is used to collect and measure beam current, verifying operation of the thruster, and giving initial estimates of thrust and ISP performance. The stand also allows for simplified placement and mounting within the chamber, as well as alignment of the thruster to the Faraday cup input. The test stand was then mounted into the micro propulsion testing chamber, centered in full view in the 6" conflat viewport, and wired up for thruster power and control.

FIGURE 21: AIS-ILIS1 V6 mounted to Faraday cup test stand

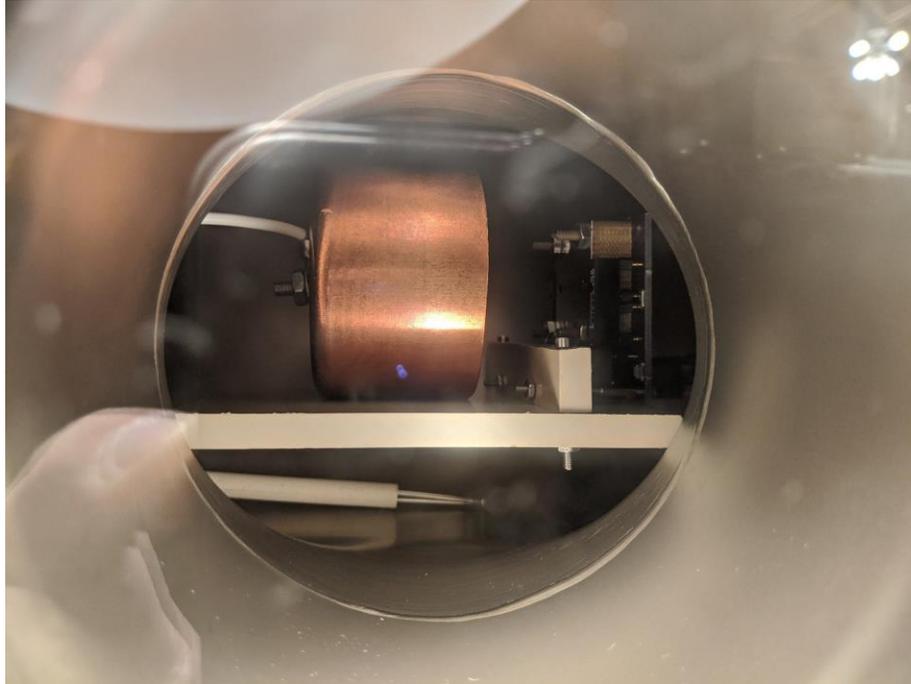
FIGURE 22: ILIS1 and Faraday cup test stand final mounting inside vacuum chamber

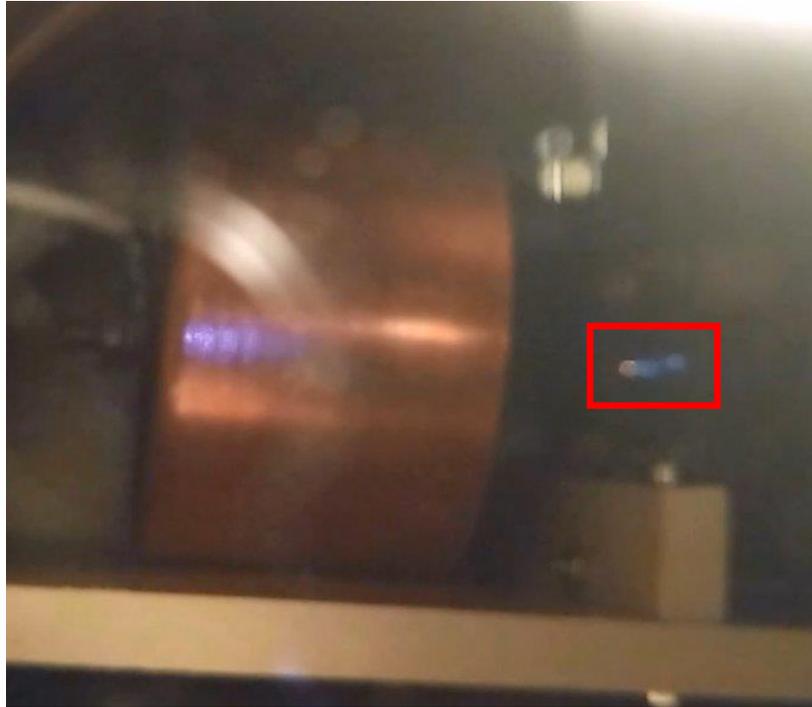
During the test, video was captured of the thruster during operation. Although the test lasted for only a few seconds before the thruster arced and failed, there was enough video captured to determine key points of fault. It was discovered that during the initial emission flash, the thruster did in fact exhibit multi-site emission along the central region of the emitter. In addition, no arcing or emission was observed at the emitter edges. This was the first time that evidence of multi-site emission along the central length of the ridge was captured for the ILIS1.

FIGURE 23: Captured ion beam emission glow from multi-site emission along the length of the ridge emitter prior to failure (outlined in red.)

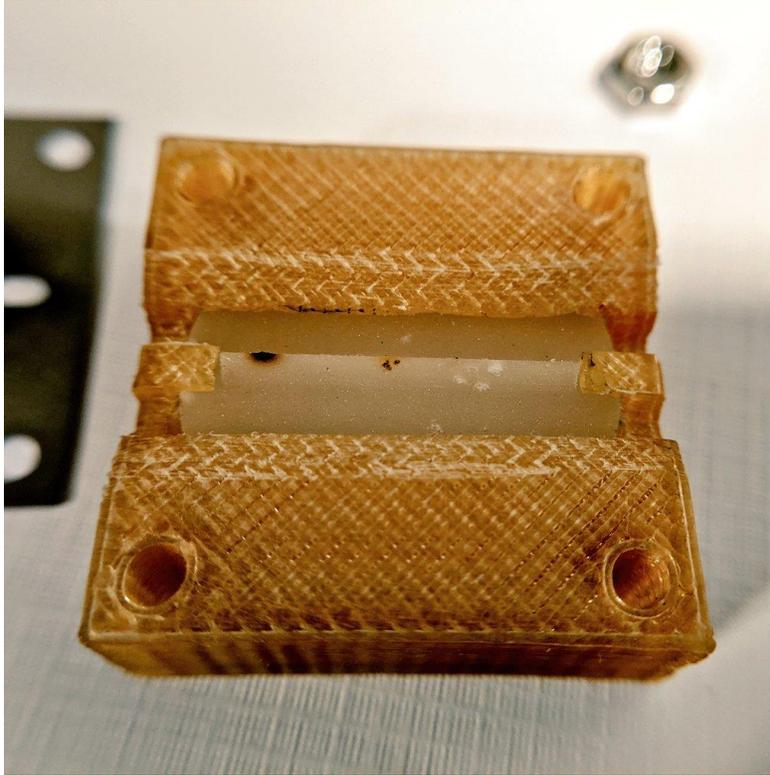
After testing the thruster was removed from the chamber for disassembly and inspection. It was immediately observed that there were several burn marks at various points along the ridge emitter, indicating the areas the thruster shorted at between the emitter and extractor. However, no burning, arcing, or emission was observed at the edges, confirming the new extractor design functioned as expected in reducing field enhancement at the corners, and forcing high field strength along the central region of the ridge.

FIGURE 24: Arcing and fuel deposit on the underside of the extractor

The third fueling and ignition test of the AIS-ILIS1 ionic liquid ion source electrospray thruster was completed. Unfortunately, spacing and tolerances were too tight between the emitter and extractor for this iteration, causing rapid shorting and failure of the thruster. Due to lack of proper indexing, as well as the microscope not having enough stage depth to view the assembled thruster, alignment was extremely difficult and had to be done visually as best as possible holding the thruster up to a light and trying to center the ridge with the narrow extractor.

Going forward, there are several major improvements that can be made to increase the chances of success. The extractor aperture must either be wider, and/or the spacing between the emitter and extractor must be increased to prevent immediate arcing or liquid bridging. In addition, proper alignment is critical for such tight tolerances, requiring better manufacturing and assembly procedures. Higher quality extractors should be investigated, and the addition of keying for assembly should be incorporated in future design iterations.
