Applied Ion Systems

AIS-TR-016

AIS-EPPT1 Micro Pulsed Plasma Thruster V1

Ignition Test 1 - 09/13/2020

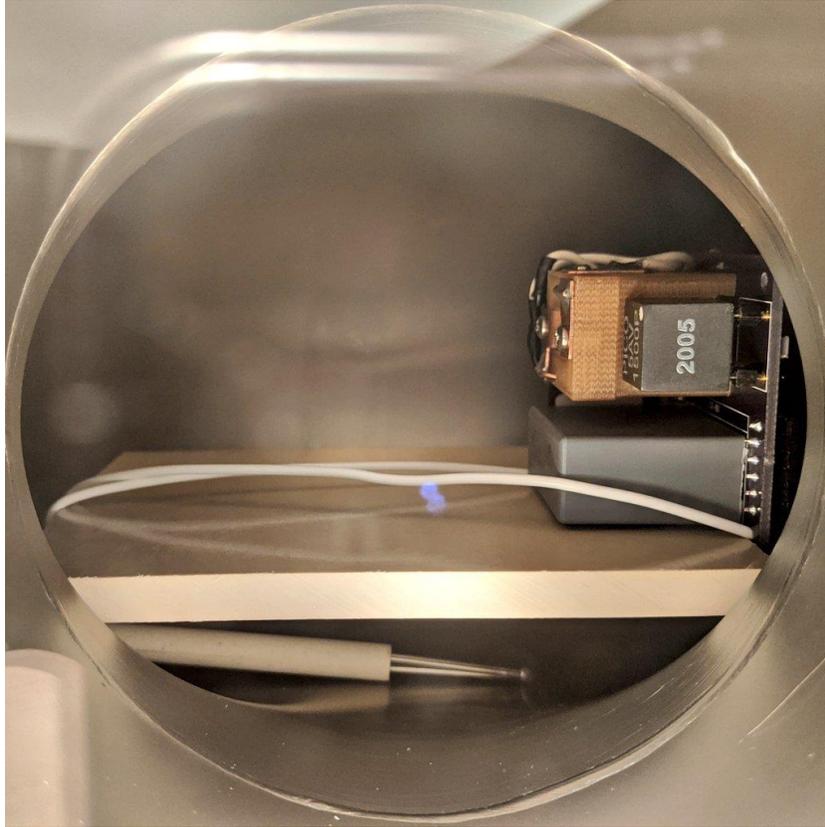
After final assembly and cleaning of the thruster, for simplicity the thruster was mounted to a flat PEEK baseplate loaded into the chamber to keep the thruster oriented properly during testing, as well as insulated away from the conductive metal vacuum chamber walls. Teflon coated wire was used to secure the thruster to the baseplate, tied through the corner mounting holes on the thruster board and wrapped around the baseplate. The thruster was then loaded into the chamber, positioned in clear view of the 6" conflat viewport, and wired for power, enable, and trigger pulse control. An external adjustable DC power supply and function generator was used to provide power and trigger control to the thruster.

FIGURE 3: EPPT1 mounted on the PEEK baseplate inside the vacuum chamber, tied down to the baseplate with Teflon coated wires.

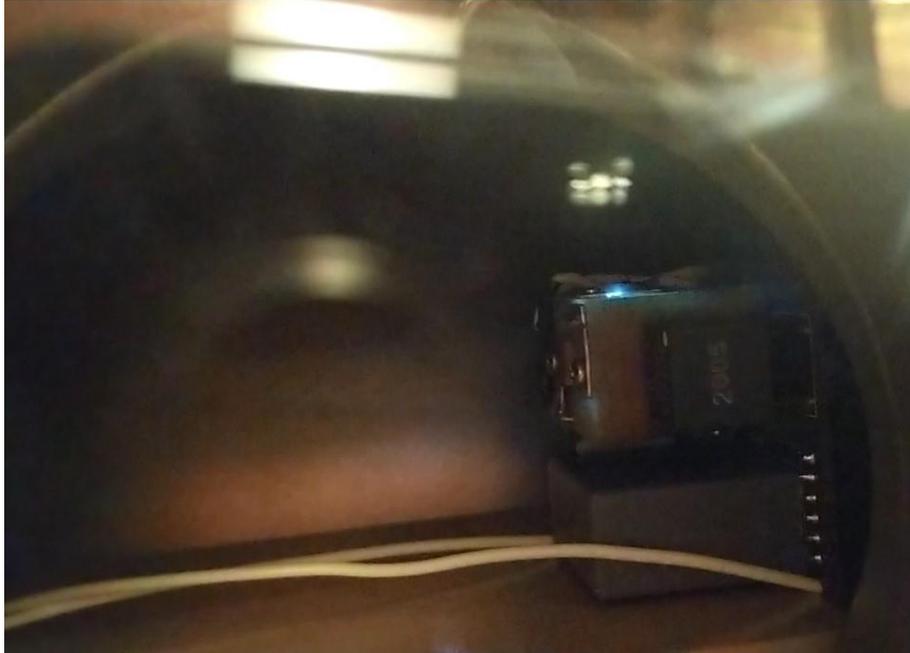
During startup of the thruster, the first fault that was noticed was a small arc that formed on the surface of the thruster, between the igniter connection and where the anode wire connection runs through the housing of the PPT. It is expected that trapped gases or outgassing lead to this initial arcing through the very thin walls, which eventually ceased after some time of pulsing.

FIGURE 5: *External arcing between the igniter connection and internal anode wire.*

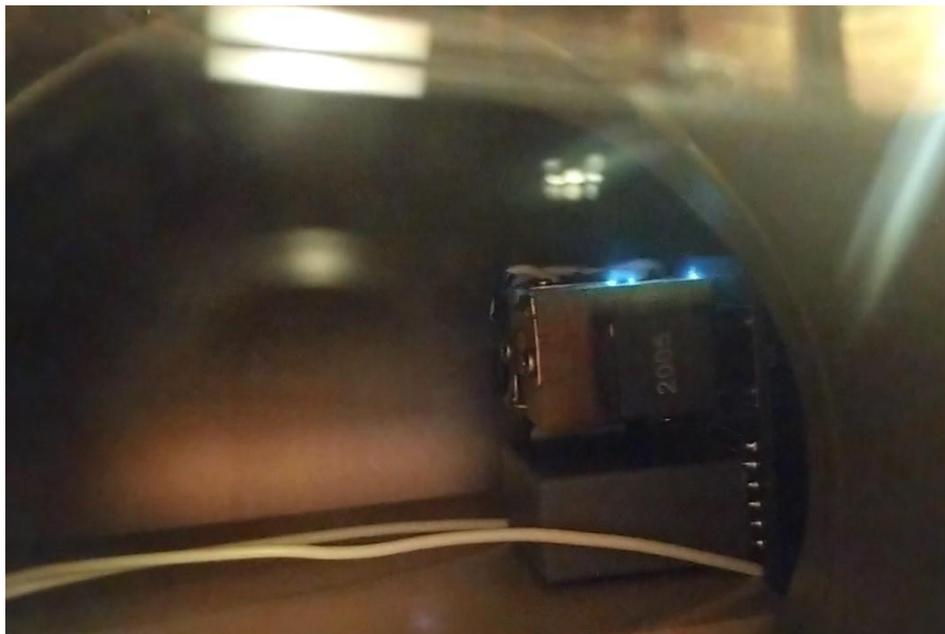
Next, several surface arcs were observed along the length of where the anode wire runs through the housing to the board. This again is most likely attributed to trapped gases being ionized, arcing from the igniter and traveling along the length of the anode connection in several locations, down to the board. This external arcing also eventually stopped after some time of pulsing the system.

FIGURE 6: *External arcing between the igniter connection and along the length of the housing to the board, tracking along the internal anode wire.*

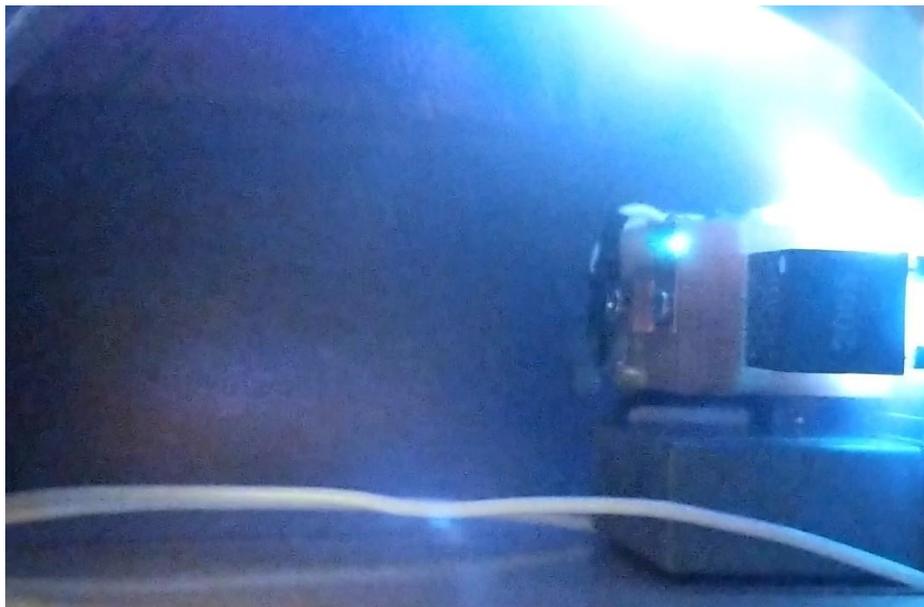
In addition, during the test a large board flash occurred during thruster operation, however no components were damaged, and the thruster continued to operate normally for the duration of the test afterwards.

FIGURE 9: *External board fault flashover.*
