Applied Ion Systems

AIS-TR-017

AIS-EPPT1 Micro Pulsed Plasma Thruster V1

Ignition Test 2 - 09/22/2020

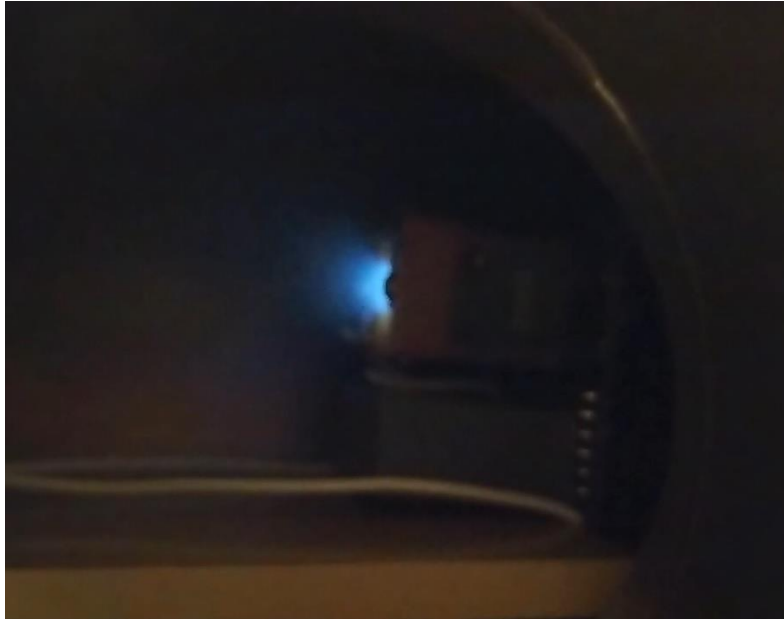
FIGURE 5: Plasma plume resulting from the ignition arc pulse alone. Intensity is significantly higher than all other PPT testing to date due to anode-side triggering.

and that the ignition arc was indeed utilizing additional energy from the main bank during the pulse. No damage to the pulse transformers were observed.
