Applied Ion Systems

AIS-TR-011

AIS-ILIS1 Ionic Liquid Ion Source Electrospray Thruster V5

Fueling and Ignition Test 2 - 07/21/2020

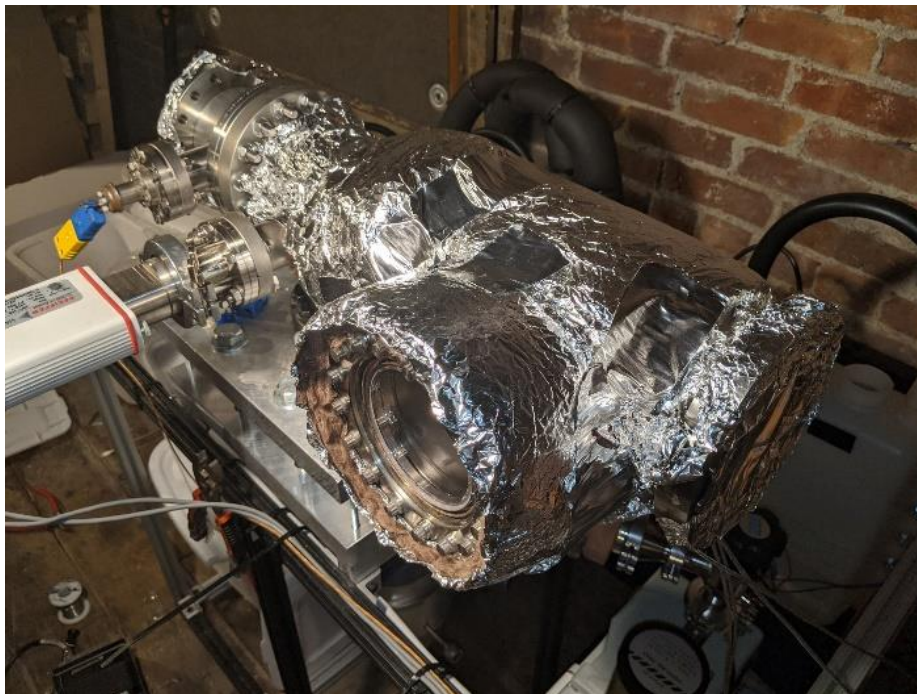
FIGURE 5: *Completed TVAC upgrade for thermal cycling and bakeout*

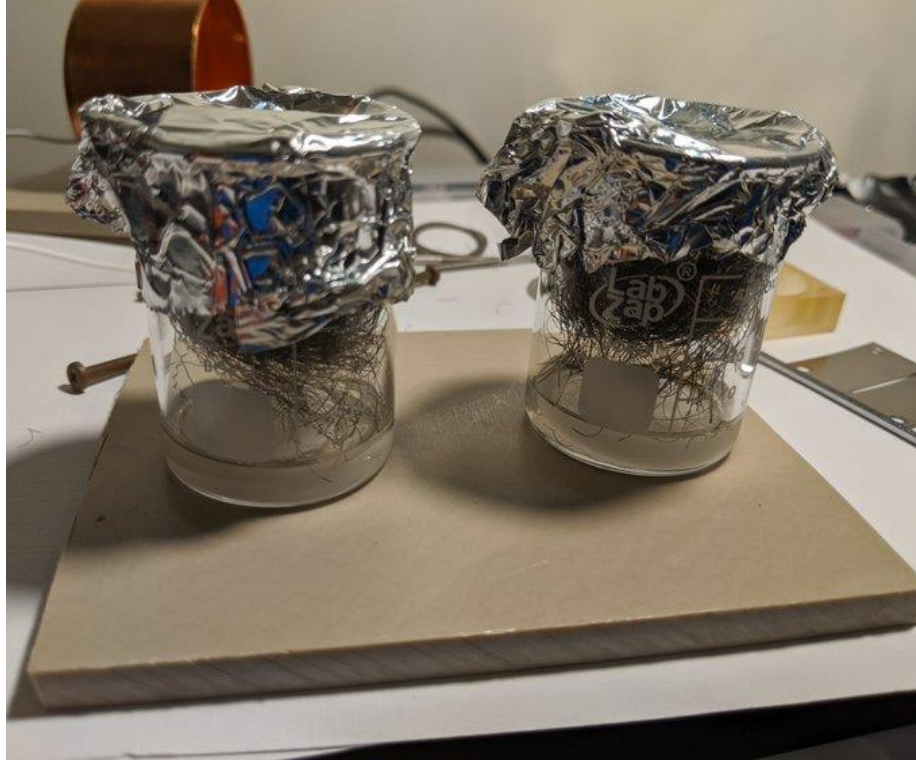
Taking lessons from the prior test, the fueling procedure was changed for this attempt. For fueling, both the porous glass emitter and reservoir were placed in their own separate Pyrex beaker, just large enough to fit the 25mm diameter discs. The beakers were then filled with ionic liquid just barely over each of the discs. The rest of each beaker was filled with 316 stainless steel wool at the top to act as a baffle to prevent excessive splattering as well as keeping the discs from bouncing around. The tops of the beakers were then covered tightly with aluminum foil to further prevent any droplet spray into the chamber during pumpdown and degassing.

FIGURE 7: Porous glass emitter and reservoir saturated in EMI-BF4

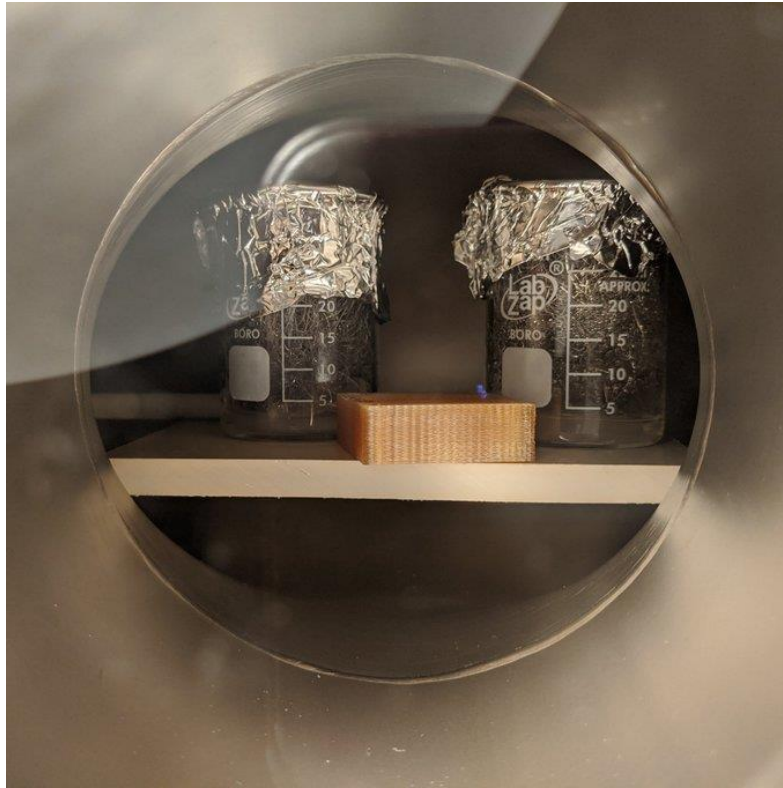
The filled beakers, as well as newly modified Ultem printed housing, and vacuum thermocouple, were mounted on a scrap PEEK baseplate that rested inside the chamber, to prevent direct heating from the chamber during bakeout. Baking was particularly important for this test preparation to better degas the plastic casing to prevent any spurious ionization due to outgassing as seen in the first ignition test, as well as better prepping the ionic liquid fuel. The system was pre-pumped with the roughing pump the night prior and sealed to facilitate faster pumpdown during the fueling phase of the test.

FIGURE 8: Saturated porous glass emitter and reservoir with Ultem housing on PEEK baseplate for baking and degassing
