AIS-TR-020

**AIS-gPPT3/EPPT1 Hybrid Micro Pulsed Plasma Thruster
Test Campaign Report and Summary**

Michael Bretti – 12/22/2020

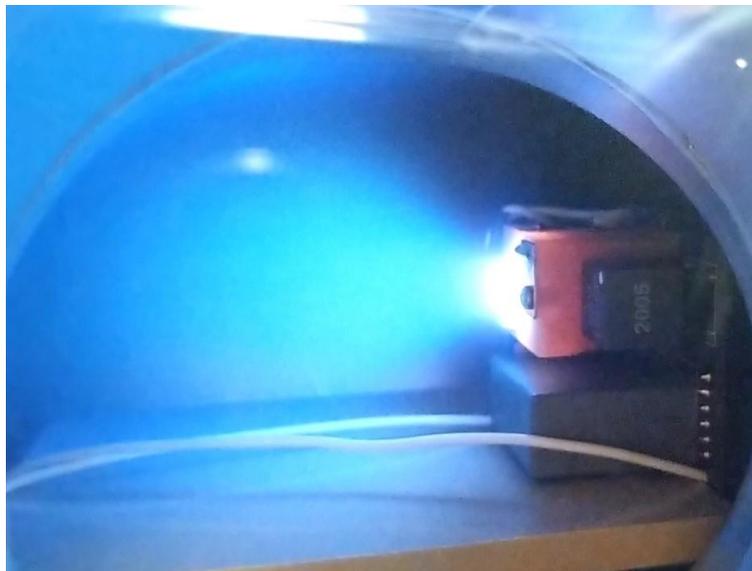
FIGURE 7: *AIS-EPPT1 plasma plume*

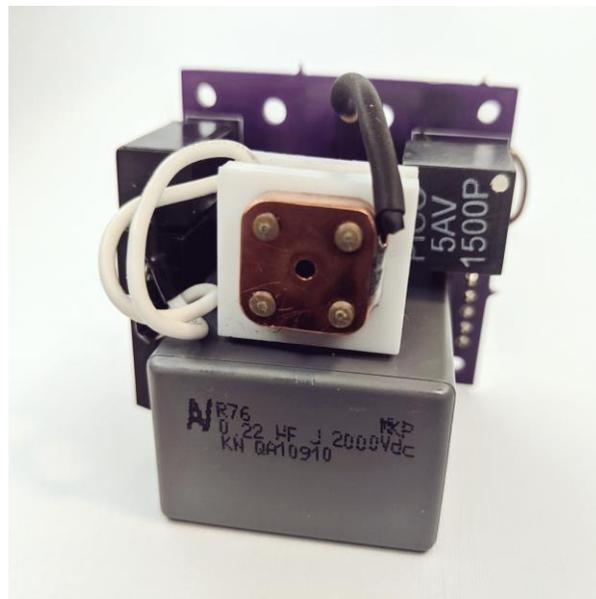
After the first test run, the EPPT1 thruster electronics were rebuilt from scratch, this time incorporating a larger 0.22uF bank, as opposed to the original 0.1uF bank. The gPPT3 thruster head was mounted the same as the prior test.

FIGURE 11: gPPT3/EPPT1 thruster assembly for ignition test 2

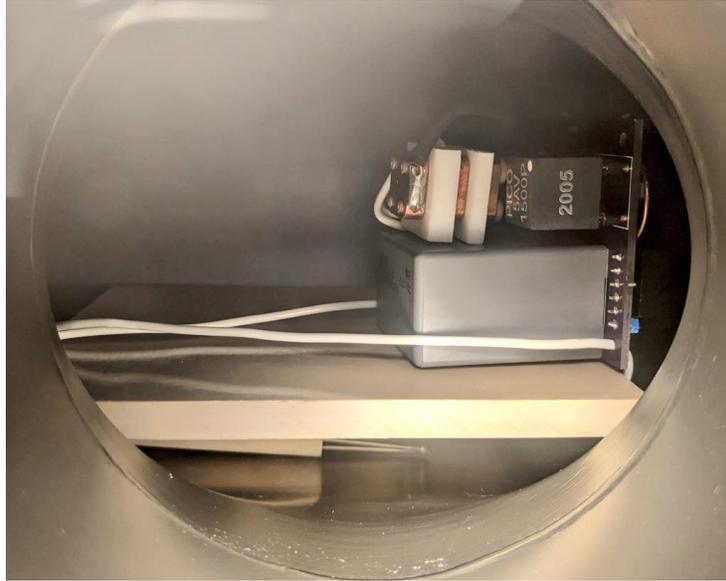
The thruster was mounted into the chamber, which was pumped down to a level of 8×10^{-6} Torr before starting the test. Unfortunately, immediately at the start of the test, the thruster experienced failure.

FIGURE 12: *Thruster mounting inside high vacuum chamber*

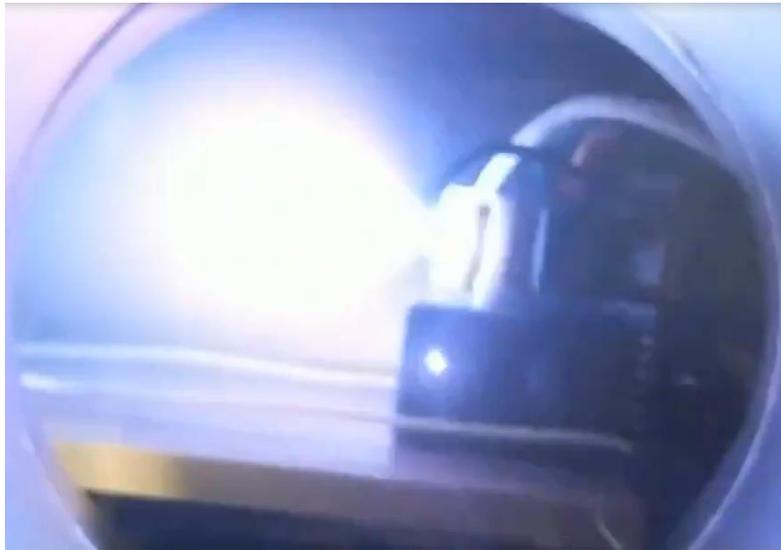
After about 10 minutes, the repetition rate was increased to 1Hz, and the system continued to fire reasonably well. During this phase, an average of 56 out of 66 shots in 60 seconds was recorded, still giving about a 15% misfire rate. Test parameters at this point were 5.5V in, 1.6kV peak out, and 0.825W power draw.

FIGURE 17: Plasma plume during thruster operation

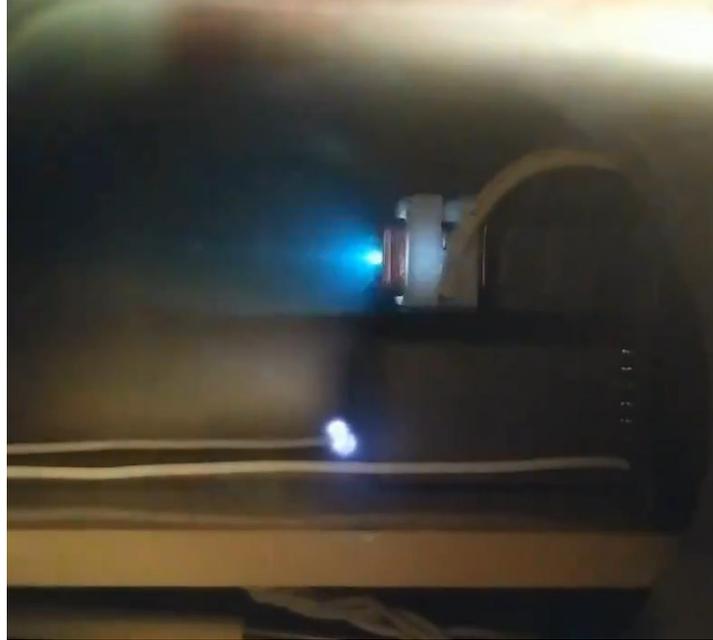
The system was pumped down to 7×10^{-6} Torr before testing. During the test, it was found that the physical plume was significantly reduced in size, appearing as a very small focused burst rather than the typical large expanding plume. Thruster operation appeared erratic with difficulty starting and mostly misfires.

FIGURE 20: *Plasma plume during thruster operation with anode-side triggering*

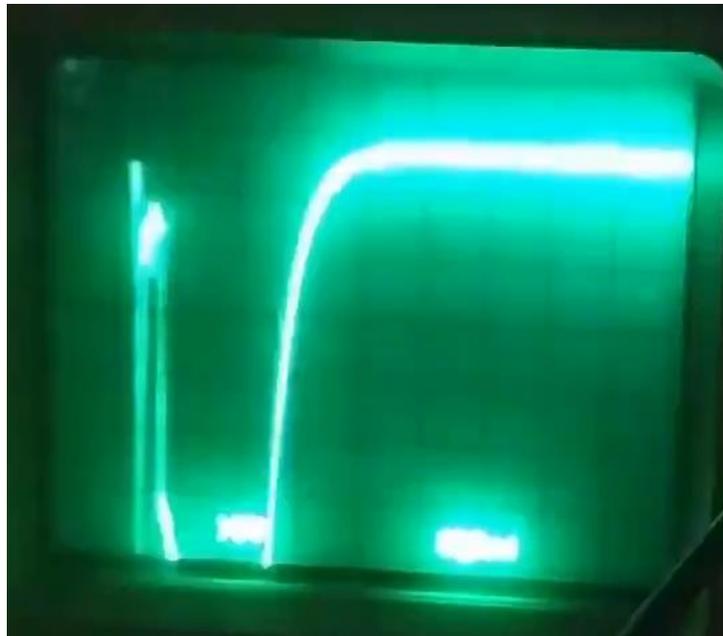
On the oscilloscope, it was also observed that instead of the typical 300ns pulse seen during standard operation of the gPPT3, the pulse width was significantly widened to 100uS. Despite the incredibly small plume, the width appeared massively changed in length during anode-side triggering operation.

FIGURE 21: *Captured pulse during firing with extended 100uS pulse width discharge*

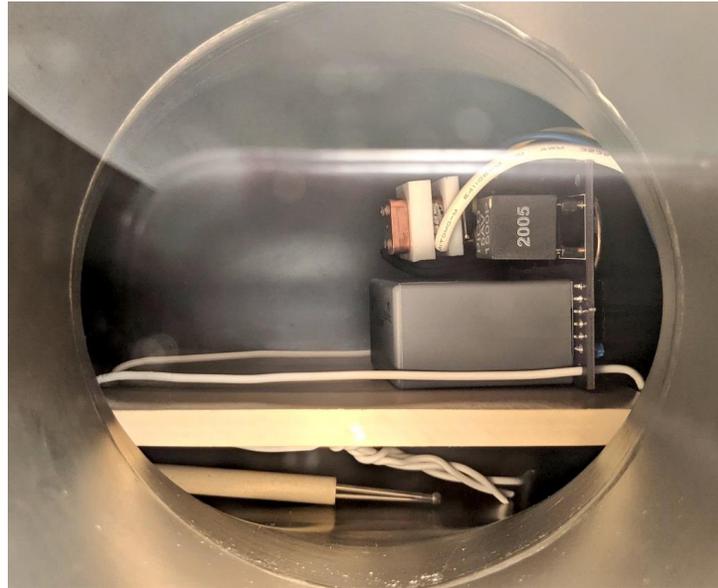
For the fifth ignition test, the thruster configuration and electronics remained the same, however the permanent magnet nozzle was removed from the anode to gauge whether or not the magnetic field was inhibiting the plume formation with the reversed polarity configuration in anode-side triggering. The system was pumped down to a level of 3.6×10^{-6} Torr prior to testing.

FIGURE 22: Thruster mounting inside high vacuum chamber

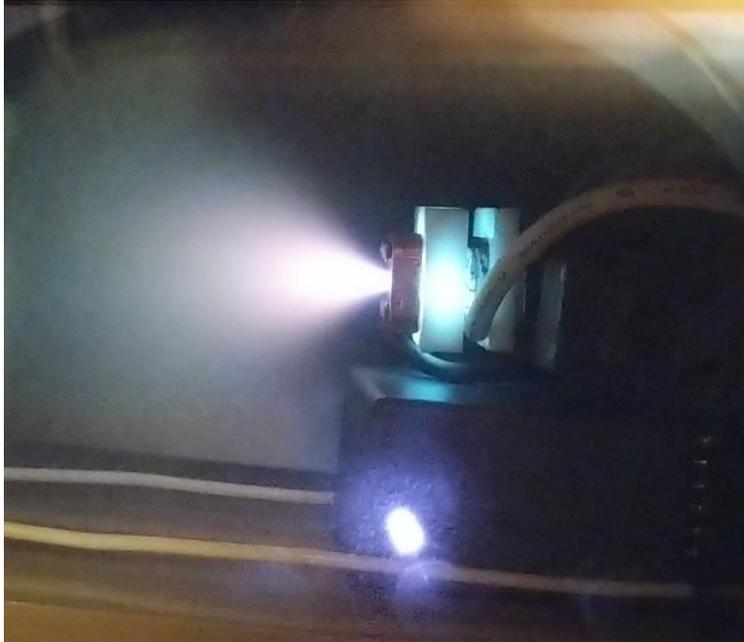
Performance was notably worse than prior tests, with almost no ignitions recorded. This however was thought to be attributed to thruster fuel depletion, as prior testing had brought the fuel bore to nearly 4000 shots, as well as general wear and carbon buildup from operation. However, a shot during successful ignition was captured. Out of all PPT testing to date at AIS, this test result was by far the most unusual. Instead of the typical blue or pink plume commonly seen with the gPPT3, and PPTs in general utilizing Teflon propellant, the resulting plume was a clean white and more focused in shape as opposed to expanding out. It is still unclear why the plume was like this, and what correlation reverse polarity configuration has on plume formation with the gPPT3 resulting in this phenomenon. However, the test did validate that the magnetic field from the permanent magnet nozzle was in fact inhibiting plume formation during operation in reverse-polarity anode-side triggering.

FIGURE 23: Plasma plume during thruster operation with anode-side triggering and no magnetic nozzle

The effects of reverse polarity on operation also needs to be studied further to see if any gains in performance can be quantified as well. While anode-side triggering appears to inhibit performance in the gPPT3, the unusual plume formation without the magnetic nozzle is of interest for future studies.
