Applied Ion Systems

AIS-TR-021

AIS-gPPT3-1C Micro Pulsed Plasma Thruster

Lifetime Test 2 - 12/06/2020

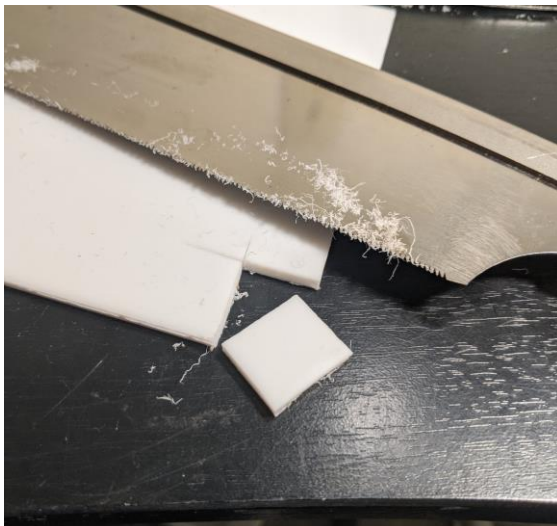
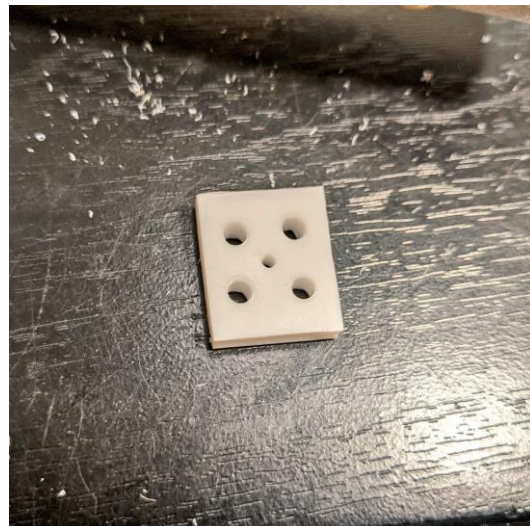
Figure 2 and 3: Modified 1/8" thick Teflon fuel plate

The thruster was started at a voltage of 3.3V in, at a low repetition rate of 0.2Hz. While all the thruster readouts indicated proper functioning of the power supply, no pulses were observed. Voltage was slowly increased to the nominal max input of 5V, where no further ignition occurred. After about 10 minutes, voltage was increased to 5.5V, where the thruster began to fire. After more reliable ignition was achieved, the thruster input voltage was turned back down to 5V. Despite initial pulsing, thruster operation was unreliable, with difficulty triggering on command. In an effort to make ignition easier, it was decided to remove the gPPT3 thruster head and modify it. The 3/16" thick Teflon fuel block, which includes a 1/16" diameter fuel bore, was replaced with a thinner 1/8" thick fuel plate with the same fuel bore diameter, effectively bringing the anode-cathode gap spacing closer.

During the test, modifications were required to provide more reliable operation. Going forward, the gPPT3 thruster head will be built with a 1/8" thick fuel plate. The permanent magnet nozzle

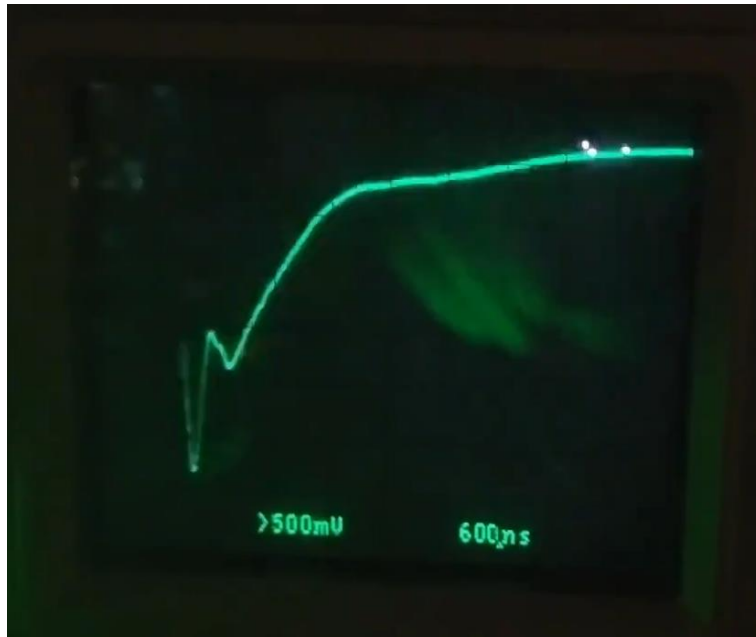
Figure 7: Captured pulse waveform during successful thruster ignition

During operation of the thruster, the resulting pulse waveform was captured on the oscilloscope via induced EMF on the Faraday cup located in the chamber. During prior testing, it was found that the induced EMF was a reasonable indicator of pulse shape, both during successful ignition as well as misfires. In this case, the pulse appears as a sharp spike, with a slowly decaying tail. This differs from testing with the magnetic nozzle and standard fuel, resulting in a distinct double-peak waveform, and without the nozzle but standard fuel, resulting in a bipolar pulse.
