# **Applied Ion Systems**

**AIS-TR-030**

**AIS-EHT1 Micro End-Hall Thruster**

**Full System Ignition Test 3 - 04/03/2021**

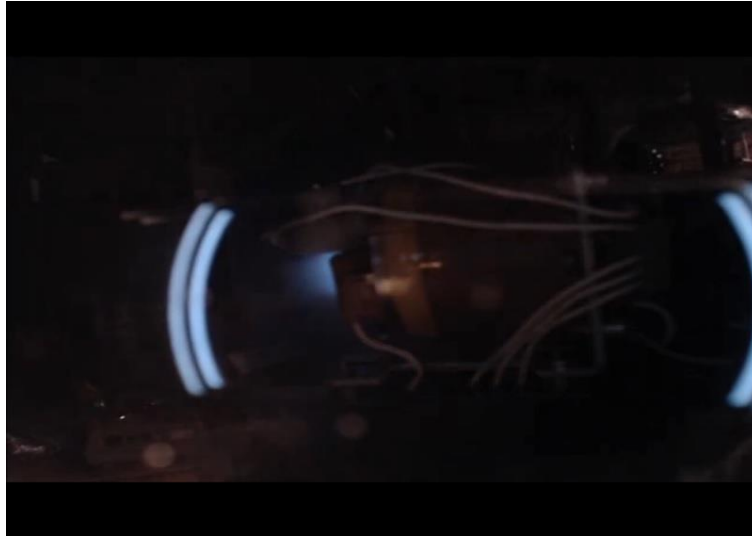
**FIGURE 7:** *Transition from plasma bridging to ignition plume.*

As the main discharge voltage was further increased, the plasma bridge began expanding outwards, and at max power achieved full plume expansion. Discharge power was 15W, and beam current on the Faraday cup was maxing out at over 500uA of beam. Total power on the system was 26W, with 15W discharge, 2W neutralizer, and the rest for sublimation heater power.
