Applied Ion Systems

AIS-TR-001

AIS-uPPT1 Micro Pulsed Plasma Thruster

Testing Report and Failure Analysis

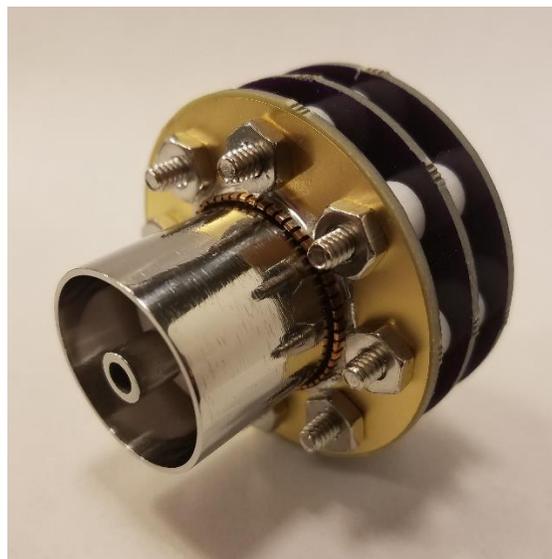
The AIS-uPPT1 thruster was mounted to the conflat feedthrough adapter utilizing a combination of Teflon clamps and a stainless-steel hose clamp. Connections to the high voltage feedthroughs were made with set screw clamps at the feedthrough end, and wire-wrapped connections to the thruster test connections at the other. Kapton tape was used to insulate the wire-wrapped connections for ease of demounting after the test. 18 AWG bare copper wire was used for the cathode, igniter, and anode connections.

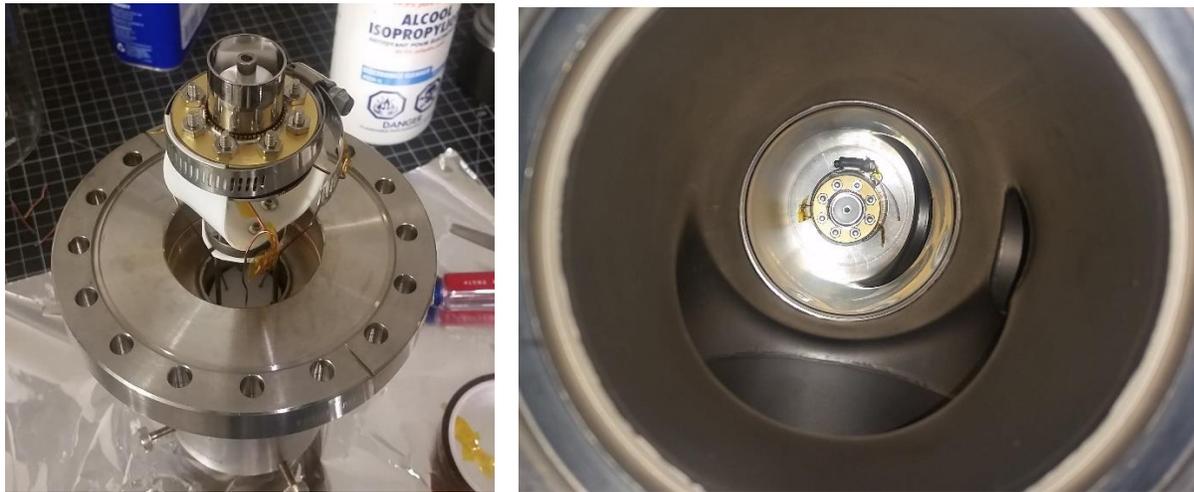
Testing was performed in the Micro Propulsion Testing Chamber using the Integrated High Vacuum Test Stand. Pumpdown conditioning of the system was achieved several days prior on 05/01/2019, which was pumped for 3 hours, achieving an ultimate vacuum of 6×10^{-6} Torr with new materials. Ignition testing vacuum levels were first verified at 1×10^{-5} Torr maximum before attempting ignition. Both the main high voltage charging supply and the thyatron trigger pulser supplies were started at 0V, and slowly raised. The ignition pulser was raised to levels until an excess of 5kV was achieved, where breakdown was observed between the cathode board and the ignition board in the PCB socket assembly. Voltages were reduced, and main bank voltage was increased to an initial voltage of 1.3kV. After repeated failed ignitions, the main bank voltage was raised to 2kV, and the ignition pulser voltage raised to peak levels over 5kV. A few random main bank discharges were observed at the rear of the socket assembly in timed synchronization with the ignition pulse, however the thruster failed to operate as designed. Ignition arcing continued to occur behind the cathode board, until the test was terminated.
