Applied Ion Systems

AIS-TR-010

AIS-ILIS1 Ionic Liquid Ion Source Electrospray Thruster V4

Fueling and Ignition Test 1 - 07/04/2020

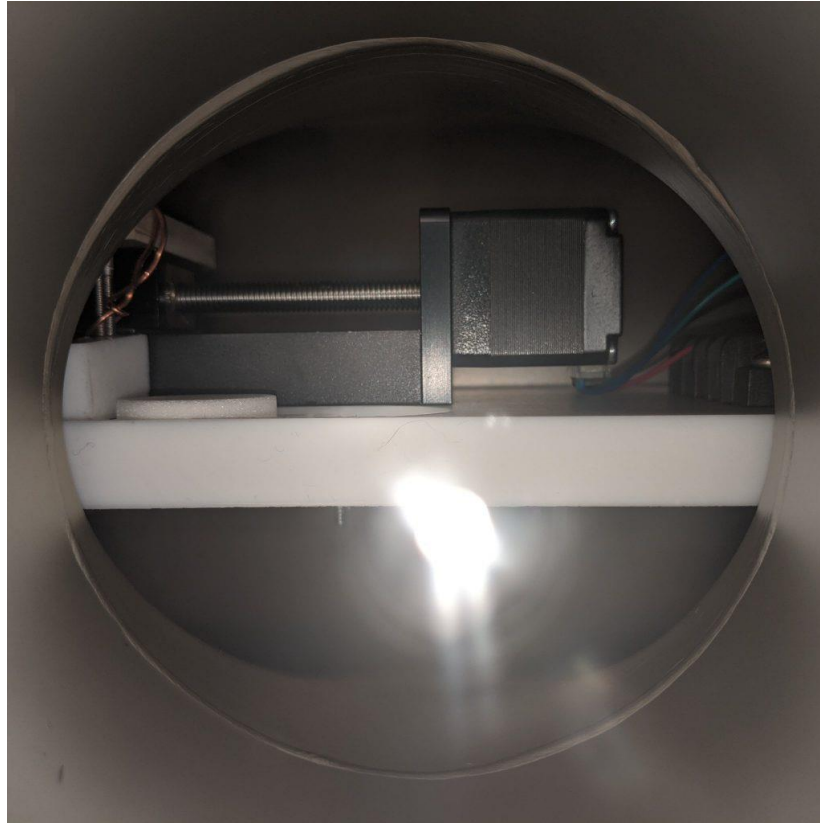
FIGURE 3: *ILIS1 fueling station with reservoir, emitter, and fuel loaded in chamber*

The roughing pump was started, with the foreline isolated from the main chamber. Once dropping below 1 Torr, the isolation valve was opened to begin evacuation of the main chamber. Immediately upon the start of pumping the main chamber, a significant amount of liquid was seen depositing all over the chamber. Pumpdown was stopped immediately to inspect the system.

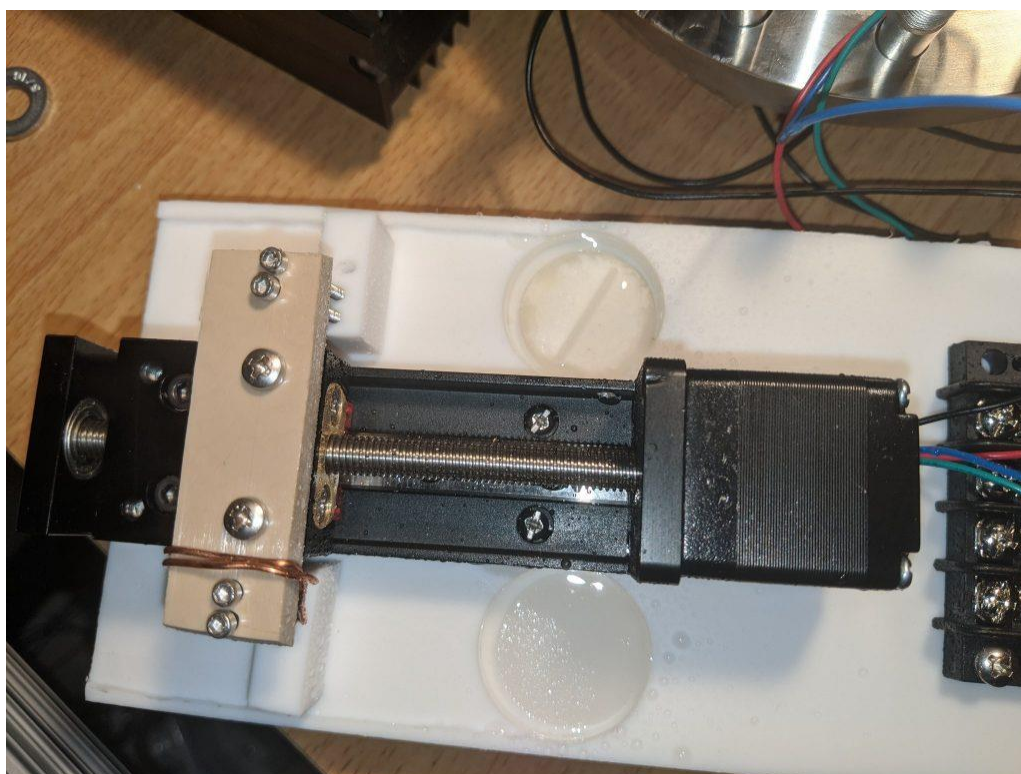
FIGURE 7: Atmospheric fueling attempt with emitter (top) and reservoir (bottom)

While the larger pores of the reservoir filled without issue, it was immediately apparent that the smaller pores of the emitter were not saturating properly. The EMI-BF₄ ionic liquid is quite viscous, and the central part of the glass emitter was not wicking up the liquid. This confirmed that the glass structures must be saturated in vacuum to achieve complete filling of the glass pores with the fuel.

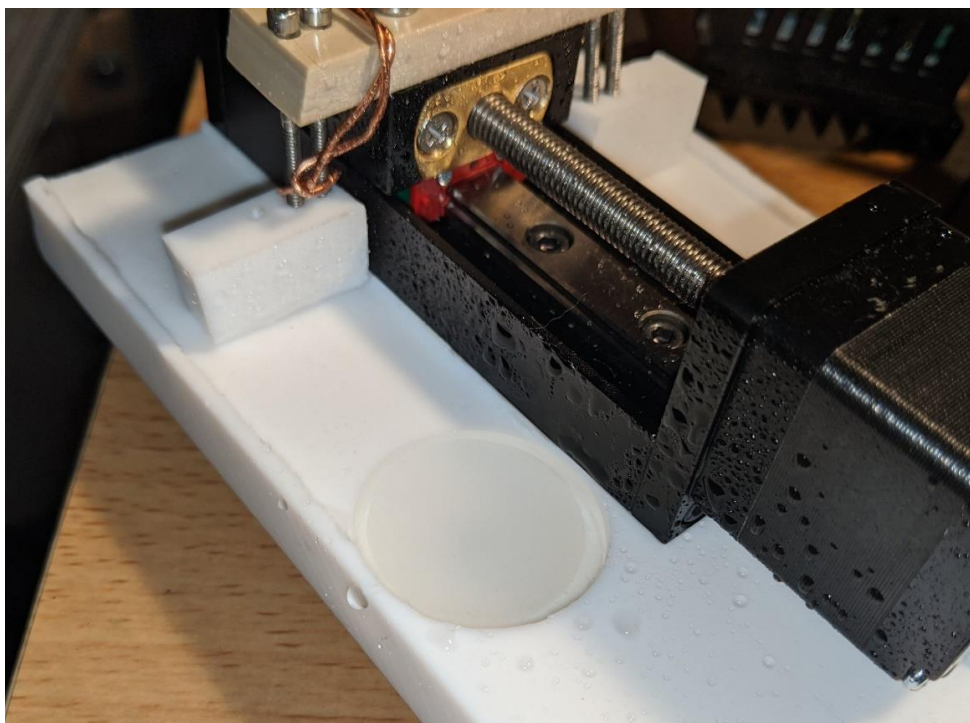
FIGURE 8: Complete saturation of the reservoir with EMI-BF₄ in atmosphere

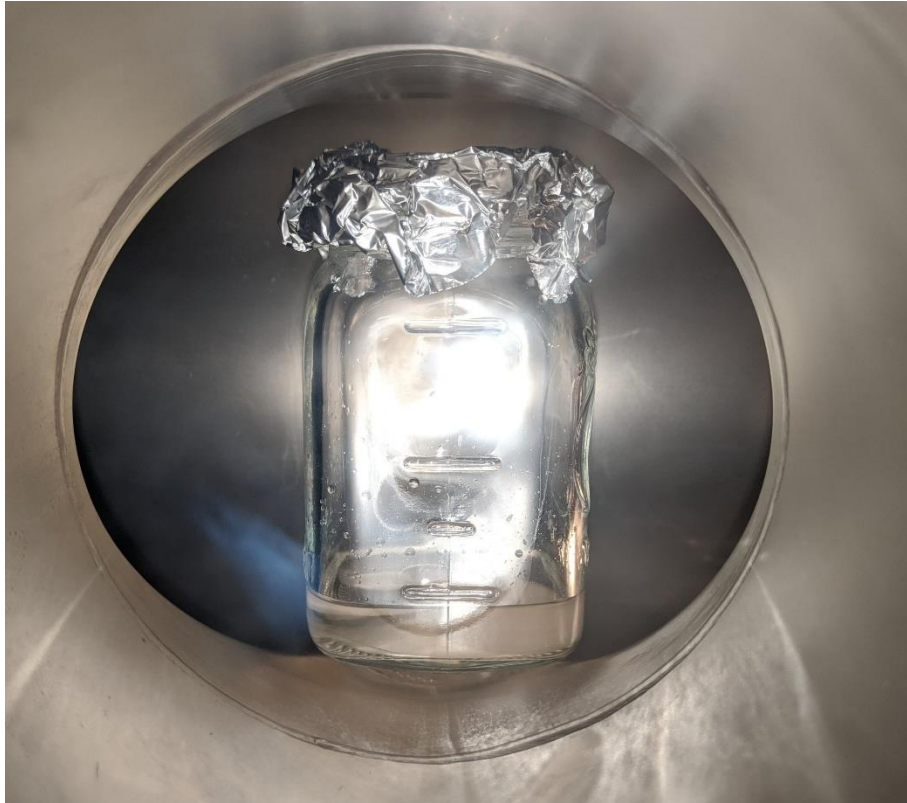
FIGURE 10: *Degassing and saturation of emitter and reservoir in vacuum in covered glass container*

Pumpdown was started again. This time, violent bubbling was noticed from the bulk liquid, with significant splashing inside the jar. Due to the high concentration of absorbed gases and water vapor in the ionic fuel, the liquid spray prior observed was in fact due to the degassing process. Severe degassing continued into the low milli-Torr range during the roughing cycle of pumping. However, no liquid spray was further observed in the chamber. The high vacuum pump was turned on, and the fuel and glass structures were allowed to continue to degas and saturate in high vacuum for several hours, until an ultimate pressure of 8×10^{-6} Torr was achieved. With this, adequate degassing of the fuel, as well as saturation of both porous glass structures were successfully achieved. The system was shut down, and preparations were made for the Phase II ignition test attempt.

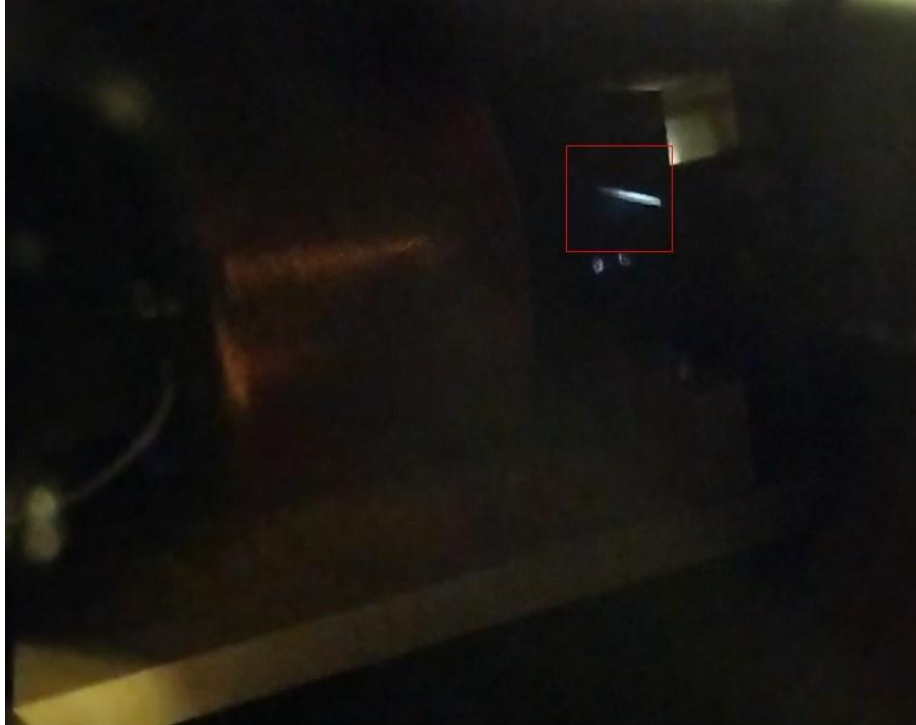
Despite the numerous board faults, controller faults, and overall failure of the ignition test to achieve stable ignition of the thruster, several brief instances of ion beam emission were observed. The intensity was far too low in all cases to capture with the current monitor readout with the Faraday cup, however there is visual confirmation of some proper ionization being achieved.

FIGURE 24: *Captured ion beam emission from extractor slit showing uniform ionization*

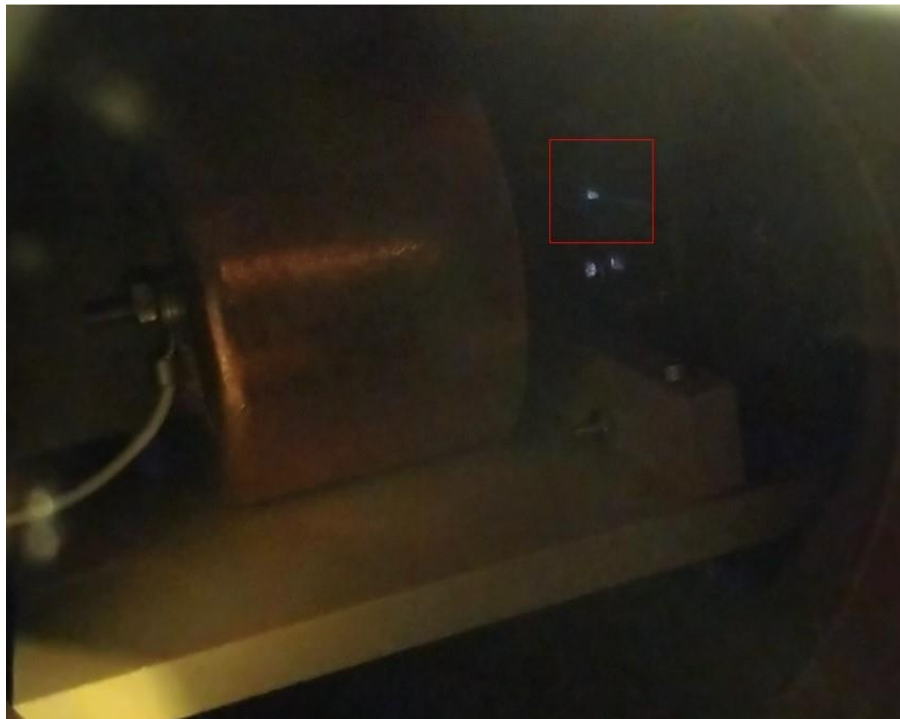
FIGURE 25: *Captured partial ion beam emission at far corner edge of the emitter*

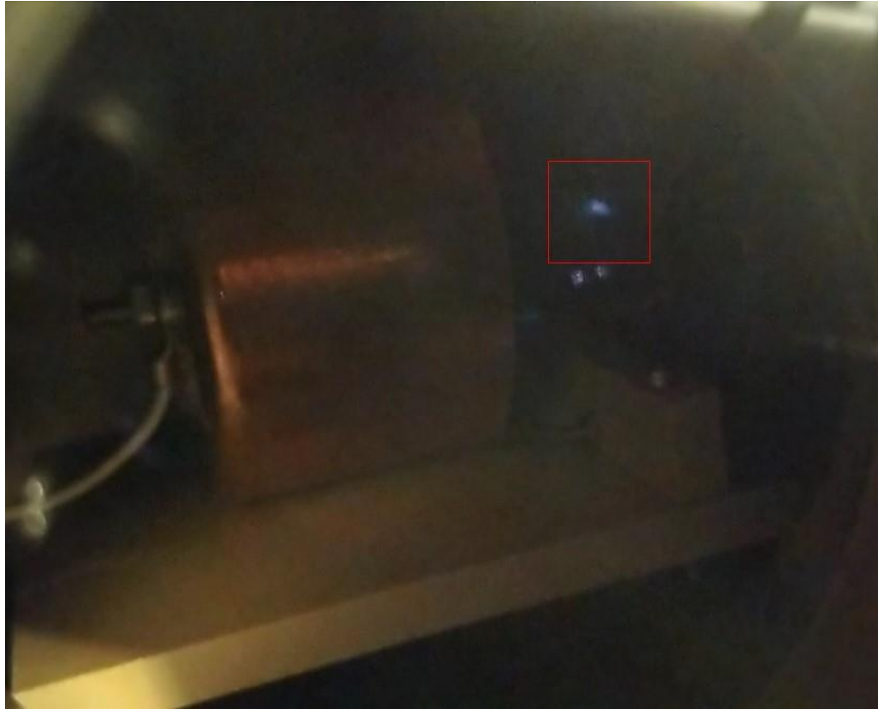
FIGURE 26: *Captured ion beam emission showing partial ionization from the central region of the emitter*
